Surface characteristics of chemical conversion coating for Mg–Al alloy

Abstract: The chemical conversion coating was formed on Mg alloy for low cost and harmlessness in environment by using the colloidal silica as the main component. The film formed at 298 K was thick, which was thought to be the combination of Si and O. In salt spray test, the ratio of black rust on the specimen that did not conducted chemical conversion treatment was five times or more than those of the chemical conversion treated specimen. The film of chemical conversion coating produced by alkali treatment process was thinner than the specimen produced in basic chemical conversion treatment solution.

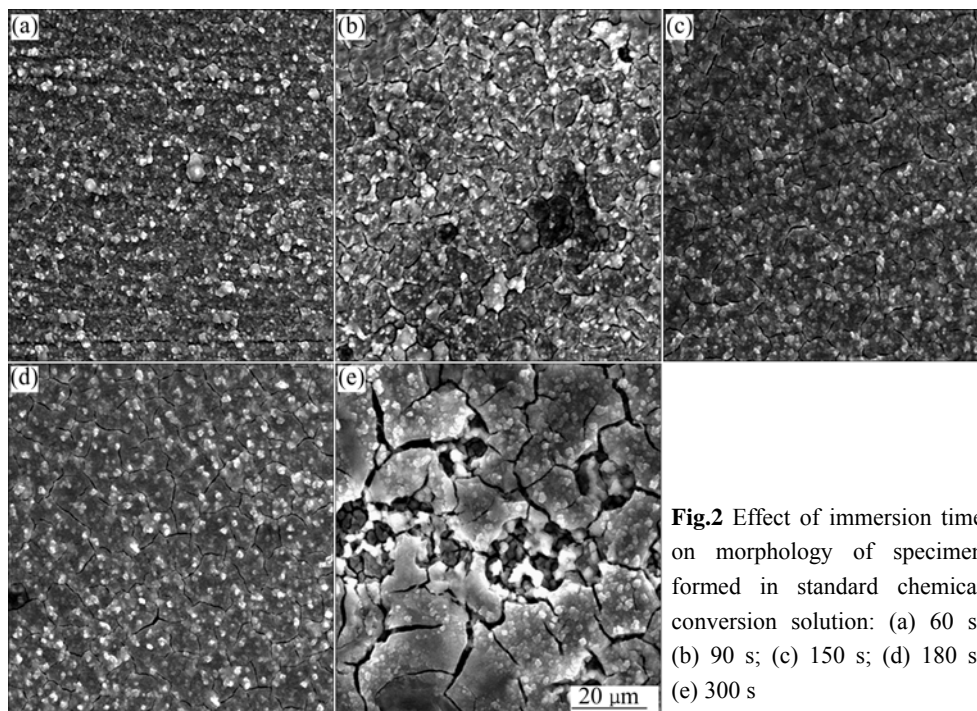
Fig.2 shows the effect of immersion time on surface morphology of specimen formed in basic chemical conversion treatment solution. The surface film formed at 60 s is not complete since scratch can be seen on the surface. The film formed at immersion time of 90–180 s does not change largely. However, the combination part of Si and O (white color parts) in 90 s is wide, and the formed film is thick. On the other hand, the film formed after immersion for 300 s becomes rough. The reason is thought that the quantity of film formed with increasing immersion time is smaller than that of dissolution by activation reaction.

Fig.2 Effect of immersion time on morphology of specimen formed in standard chemical conversion solution: (a) 60 s; (b) 90 s; (c) 150 s; (d) 180 s; (e) 300 s

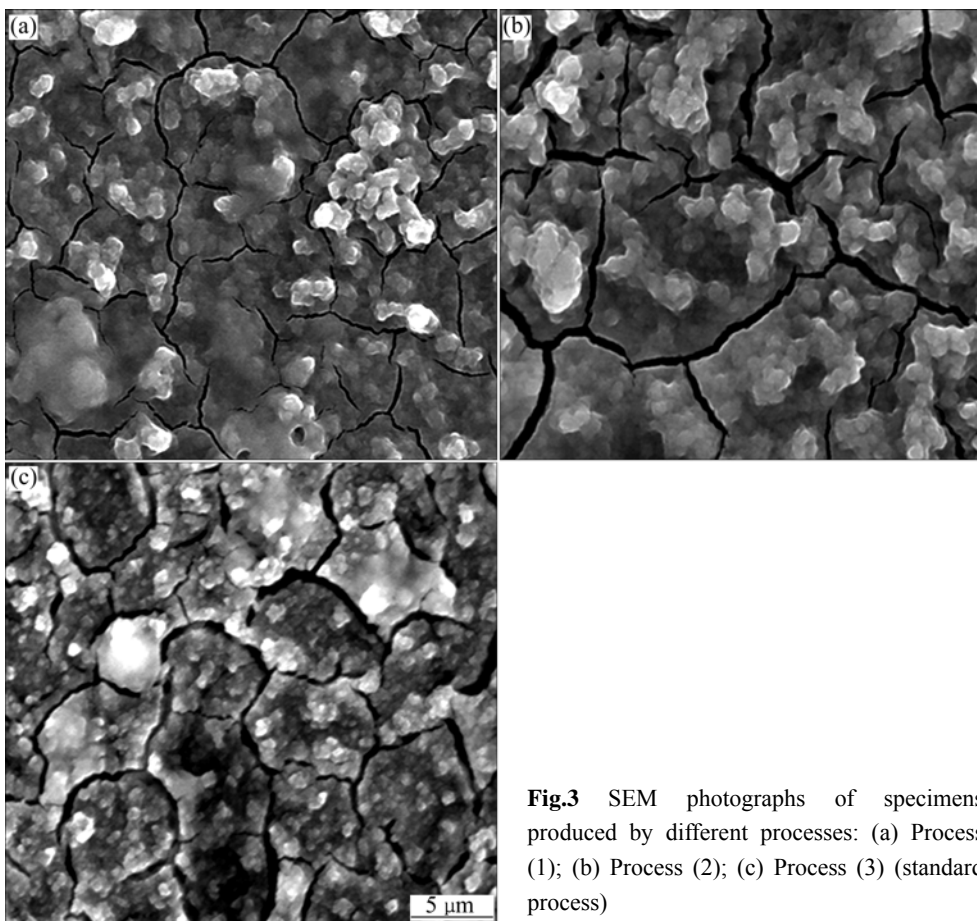
SEM photographs of specimen surface produced from alkali treatment Process (1)–(3) are shown in Fig.3. The combination of Si and O (white parts) on the surface of chemical conversion coating (Fig.3(a)) which is produced by alkali treatment before the activation in the

nitric acid is dispersed compared with chemical conversion coating produced in basic conditions (Fig.3(c)). On the surface of chemical conversion coating formed from Process (1), the microcracks are fine and uniform. The microcracks in specimen surface formed by

Fig.3 SEM photographs of specimens produced by different processes: (a) Process (1); (b) Process (2); (c) Process (3) (standard process)

Process (2) are larger compared with that by Process (1). It is thought that the magnesium alloy is unevenly dissolved since standard process (Process (3)) is activated, and the hydroxide film on the surface by alkali treatment is formed. Fig.4 shows the anodic polarization curves of the chemical conversion coating formed in basic condition, and Process (1), (2), (3). The potential with the increase of anodic current decreases in comparison with that in basic treatment condition. The Process (1) among various conditions is slightly high, but corrosion resistance does not improve. The microcracks in the film formed on the surface by anodizing of the magnesium alloy were sealed by hot water[8–10]. In the same way, sealing treatment was conducted after chemical conversion treatment to bury microcracks. It is thought that the hydration oxide is formed by the hydration reaction with the film, and the volume of the film expands[11]. Then, the Process (4) by hot water was carried out after chemical conversion treatment process in basic condition.

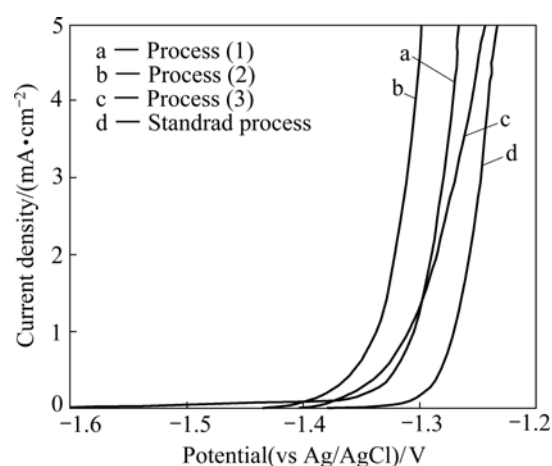
Fig.4 Anodic polarization curves after chemical conversion treatment

treatment solution condition. Furthermore, the distribution of chemical composition was very irregular. It is thought that the adhesion between the chemical conversion coating and the base metal is deteriorated because hot water makes microcracks dissolve in the silica type chemical conversion coating. In the anodic polarization experiment, the corrosion resistance in sealing by hot water after chemical conversion treatment in basic condition gets worse than that in basic condition.

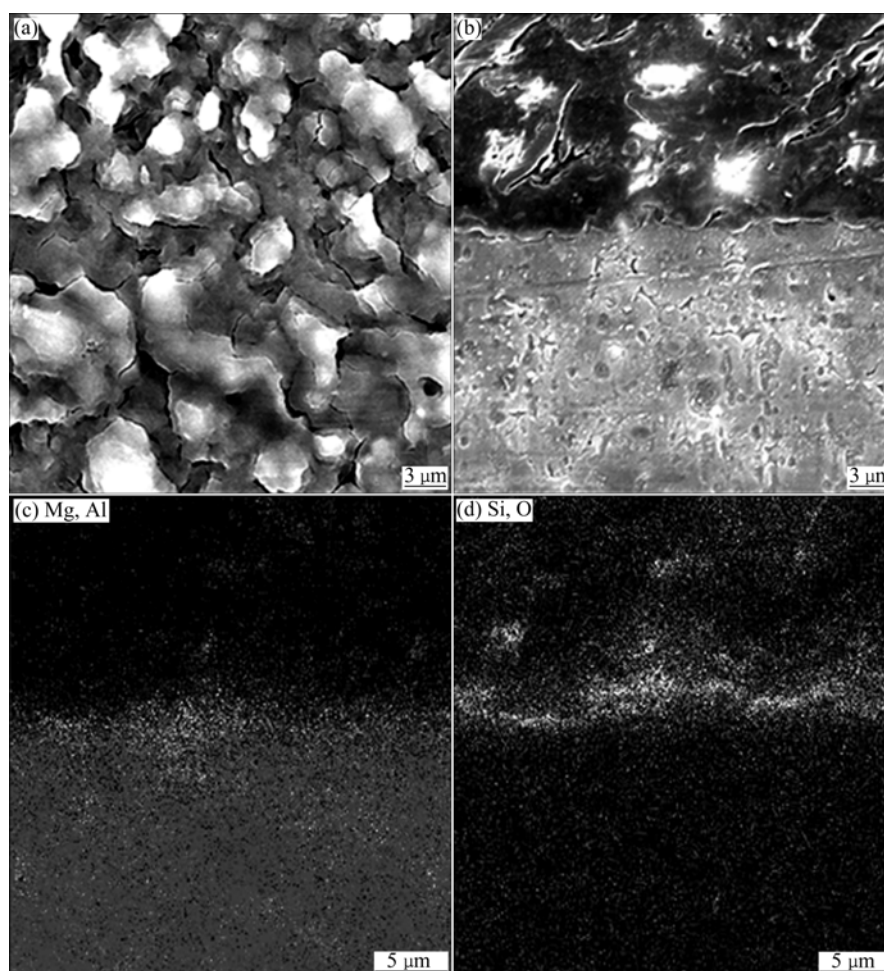
The SEM photograph, and EDX cross-section analysis of the specimen surface produced by Process (4), are shown in Fig.5. It is seen that the microcracks of the

specimen surface after the hot water treatment became fine in comparison with the specimen produced in basic solution condition. From the result of EDX analysis, the chemical conversion coating formed by Process (4) became thinner than the chemical conversion coating (2–3 μm) produced under basic chemical conversion

Fig.5 SEM photographs (a, b) and EDX cross-sectional analysis (c, d) on chemical conversion coating in hot water for 10 min at 373 K

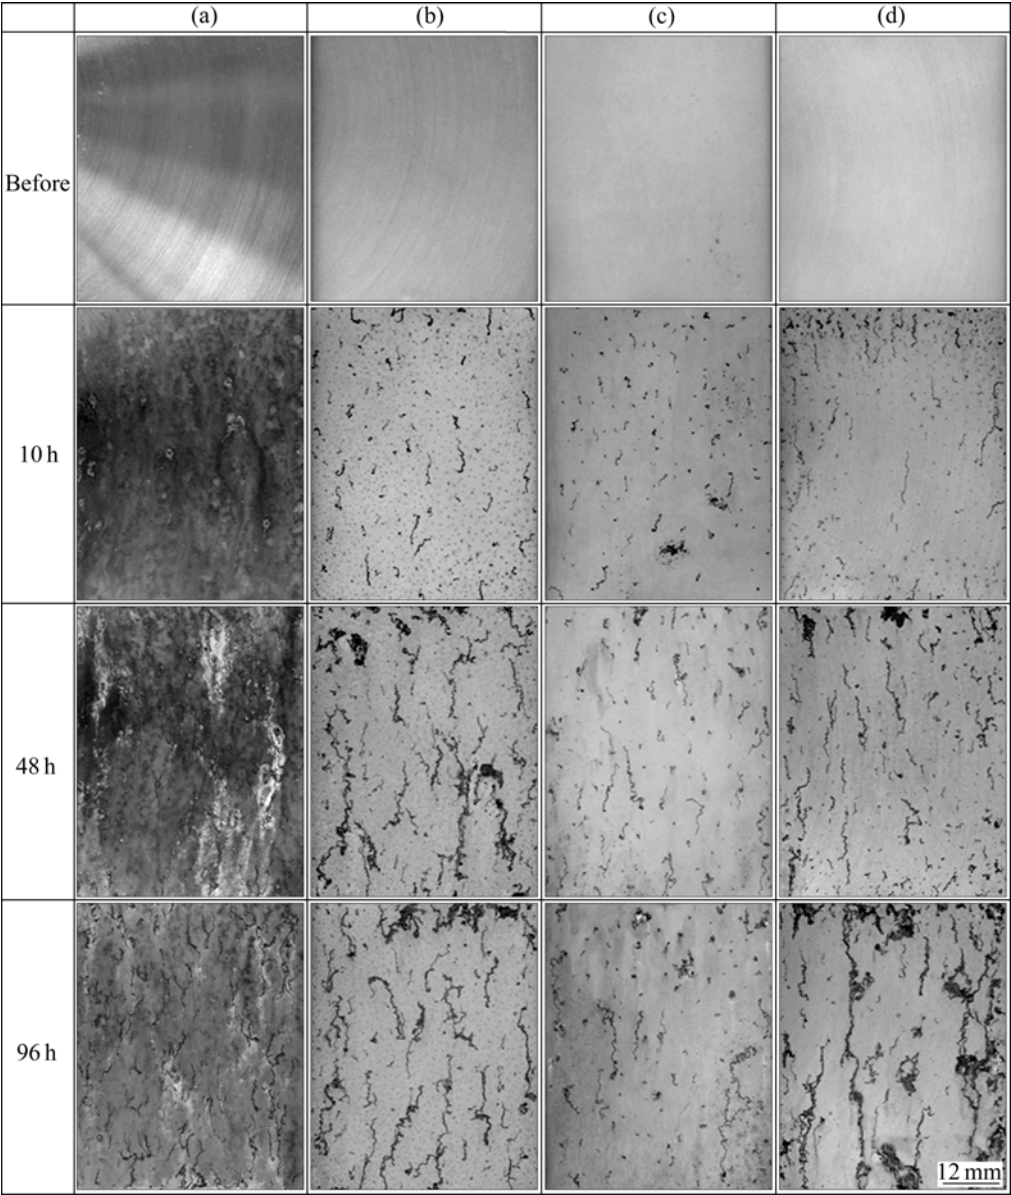
Fig.6 shows the morphologies of salt spray test of chemical conversion coating on AZ91D formed in various solution conditions. Each specimen after salt spray test for 10, 48, 96 h was washed, dried, and observed. The surface of specimen of only polishing (Fig.6(a)) formed the black rust and the white rust after the salt spray test for 10 h. The corrosion range expanded

with time increasing. Simultaneously it cannot judge that the filamentous rust exists clearly until 10 h. The black filamentous rust appeared at 48 h, and the rust grew with time increasing. The area ratio of the black rust to whole specimen area appeared to be 27.95% after 10 h, 33.84% after 48 h, and 43.61% after 96 h. The specimen produced under basic chemical conversion treatment condition (Fig.6(b)) showed the rust on the surface after salt spray test for 10 h. The filamentous rust grew with salt spraying time increasing. The area ratios of the black rust after 10, 48, and 96 h were 1.57%, 6.24% and 9.62%, respectively. The white rust could not be verified almost. In alkali treatment process, the specimen of Process (1) had the similar appearance color to the specimen produced at standard condition. After the salt spraying test for 10 h, the black filamentous rust grew gradually

Fig.6 Morphologies of chemical conversion coating after salt spray test (white color on whole surface, black filamentous): (a) After polishing only; (b) Under standard condition; (c) By coating in alkali treatment; (d) In hot water

and the area ratios were 1.03% for 48 h and 3.66% for 96 h, respectively. And also, the specimens of Process (2), (3) and hot water treatment had the similar appearance color to the specimen produced in standard condition. In Process (2), the black filamentous rust generated after 10 h was 1.69%, 2.88% after 48 h, and 3.90% after 96 h. In Process (3), the black filamentous rust produced after 10 h occupied 0.72% of the total area, 1.63% after 48 h, and 2.74% after 96 h. The area ratio of the filamentous black rust on film produced by alkali treatment was almost the same. It was decreased compared with that of chemical conversion coating produced in standard condition. In Process (4), the black filamentous rust after the salt spraying test for 10 h occupied 2.66% of the total area, 4.46% for 48 h, 8.92% for 96 h. The filamentous rust was almost the same as film produced in standard condition. The ratio of black rust on specimen which did not conduct chemical conversion treatment was five times or more than that of chemical conversion treated specimen. The specimens of the Process (1), (2) and (3) which executed alkaline treatment have almost similar corrosion-resistant quality, while the specimen of the Process (3) after salt spray test for 96 h shows the lowest ratio of black rust.
