Trans. Nonferrous Met. Soc. China 27(2017) 1087–1095

Enhanced corrosion performance of magnesium phosphate conversion coating on AZ31 magnesium alloy

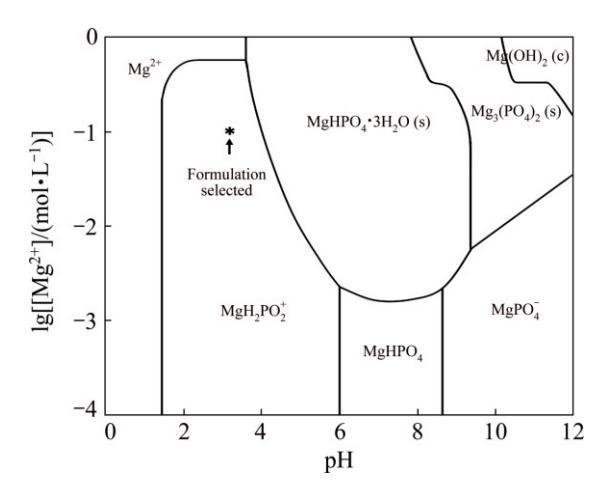
Fig. 1 Thermodynamic stability diagram showing $[Mg^{2+}]$ and pH levels for precipitation of magnesium phosphate compounds, calculated using MEDUSA software package [49] at $[PO_4^{3-}]=0.24$ mol/L, $[Mg^{2+}]$ from 10^{-4} to 1 mol/L and pH from 0 to 12

The formation of MPCC from selected MPCC solution can be explained by using the thermodynamic stability diagram, which shows $[Mg^{2+}]$ and pH levels for precipitation of magnesium phosphate/hydroxide compounds (Fig. 1). The selected MPCC solution at $[Mg^{2+}]=0.1$ mol/L (or $lg[Mg^{2+}]=-1$) and pH 3.2 is indicated by asterisk (*), suggesting that it will exist primarily in the form of soluble $MgH_2PO_4^+$ ions. The immersion of the AZ31 sample in the acidic MPCC solution 1) and hydrogen evolution (reaction 2) on the alloy surface, by which magnesium ions and hydrogen gas bubbles are

The generation of Mg^{2+} and the consumption of H^+ ions increase both Mg^{2+} concentration and pH at the near metal surface. As seen in Fig. 1, with increasing Mg^{2+} concentration and pH, several magnesium compounds such as MgHPO₄·3H₂O, Mg₃(PO₄)₂ and Mg(OH)₂/MgO can be formed (reactions (3–6)).

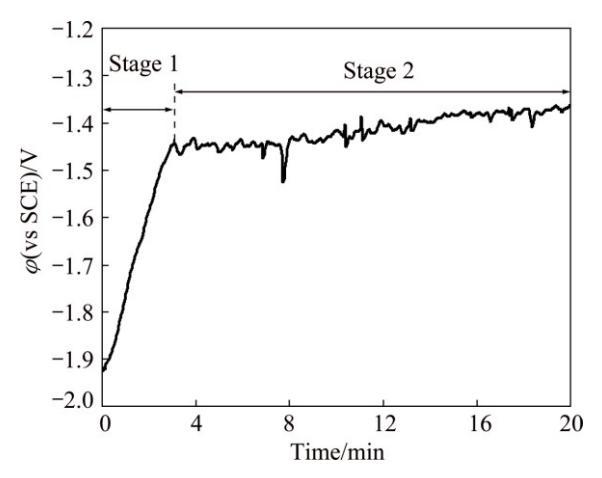
Fig. 2 OCP transient of AZ31 Mg alloy in MPCC solution at 45 $^{\circ}\mathrm{C}$

Figure 2 shows the OCP transient of the AZ31 Mg alloy immersed in the MPCC solution for 20 min. The shifting of OCP towards a more positive value indicates that the formation process of coating occurs and the coating formed is more thermodynamically stable than the original surface. The OCP transient can be divided into two stages, as indicated in Fig. 2. In the first stage up to 3 min of immersion time, the OCP was rapidly increased from an initial value of approximately -1.92 V to about -1.45 V (vs SCE), which indicated the precipitation and rapid growing process of the coating on the surface. During the second stage, after 3 min of immersion time, the OCP slightly increased, which suggests that the thickness of the MPCC is being further developed. Some potential fluctuations observed in the second stage are associated with the processes of dissolution and repassivation at some parts of the coating during the conversion coating process.

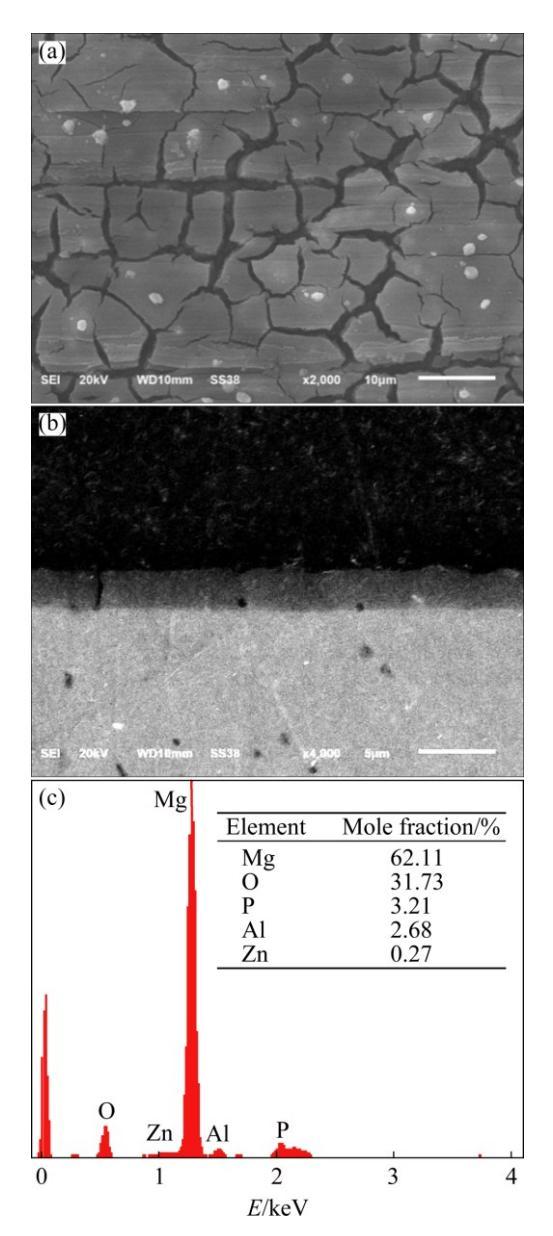
Fig. 3 SEM images of surface (a) and cross-sectional morphologies (b), and EDS area analysis (c) of MPCC on AZ31 after 20 min treatment time in MPCC solution at $45 \text{ }^{\circ}\text{C}$

Figures 3(a) and (b) show SEM images of the surface and cross-sectional morphologies of MPCC coated AZ31 after 20 min of treatment time. The MPCC on AZ31 exhibited micro-cracked structure. The micro-cracked structure is commonly seen on the surface of chemical conversion coated Mg alloys such as with chromium, permanganate and cerium conversion coatings [5,10–13]. Cracks are likely due to the lower molar volume of MPCC resulting from dehydration during the immersion treatment. The coating was otherwise smooth and exhibited a uniform thickness of about 2.5 μ m after 20 min of phosphating treatment.

Figure 3(c) shows the EDS area analyses of the MPCC on AZ31. It was found that the coating consists of Mg (62.11 %), O (31.73 %), P (3.21 %), Al (2.68 %) and Zn (0.27 %). Thus, this result suggests that the coating was mainly composed of MgO/Mg(OH)₂ and Mg–PO₄ compounds.

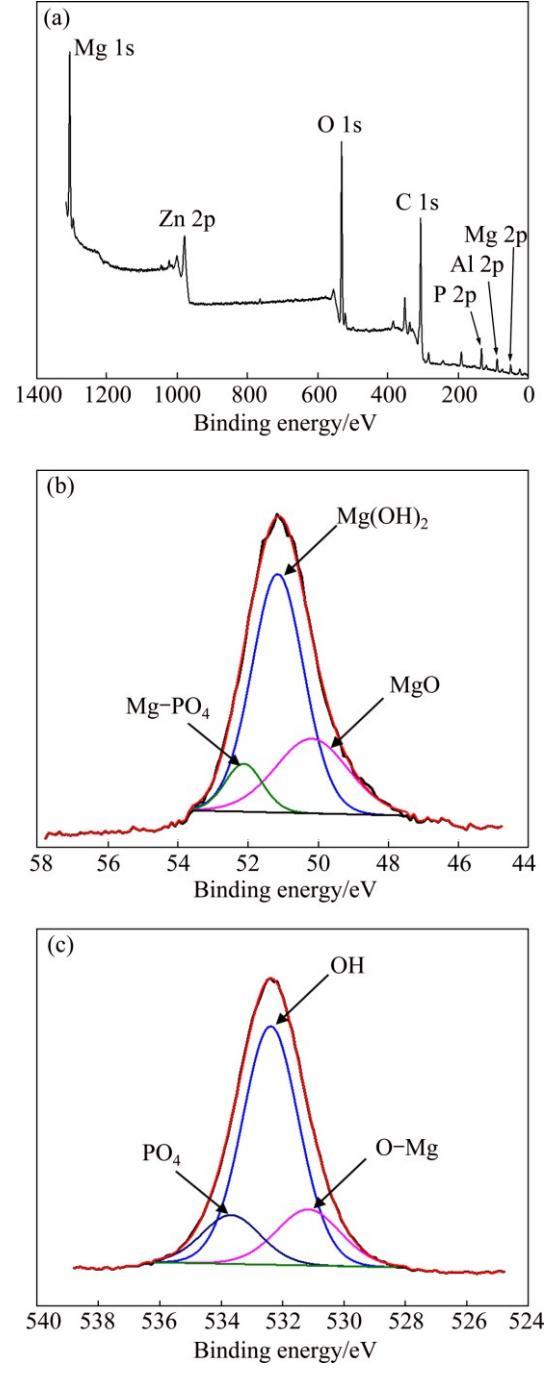
Fig. 4 XPS analyses of MPCC coated AZ31: (a) Survey; high resolution of Mg 2p (b) and O 1s (c)

To provide better understanding of the chemical composition of MPCC on AZ31, XPS was used to study the surface bonding of the coating (Fig. 4). XPS survey spectrum of coating found that the main constituents of the coating surface included magnesium, aluminum, zinc, oxygen and phosphorous species (Fig. 4(a)). Highresolution XPS scan (Fig. 4(b)) further shows the Mg 2p binding energies appearing at approximately peaks of 50.19, 51.16 and 52.13 eV, which correspond with the bonding of MgO, Mg(OH)₂ and Mg-PO₄, respectively. For the O 1s binding energy (Fig. 4(c)), three peaks at binding energies of 531.16, 532.39 and 533.67 eV were fitted, which correspond with the bonding of metal oxide (MgO), hydroxide $(Mg(OH)_2)$ and phosphate (PO_4) compounds, respectively. Thus, both EDS and XPS analyses indicated that the MPCC on AZ31 was composed of MgO/Mg(OH)₂ and Mg-PO₄ compounds, such as MgHPO₄·3H₂O and Mg₃(PO₄)₂.

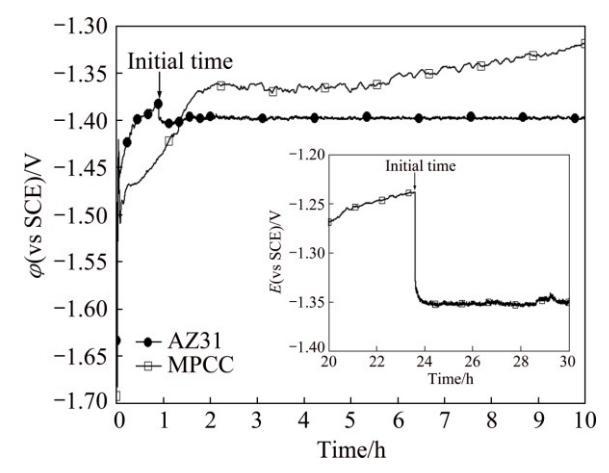
Fig. 5 OCPs of bare and MPCC coated AZ31 with immersion time immersed in 0.1 mol/L NaCl solution at 25 °C (Inserted figure was OCP of MPCC sample with immersion time of 20 to 30 h)

Figure 5 shows the OCPs of bare and MPCC coated AZ31 as a function of time immersed in 0.1 mol/L NaCl solution at 25 °C. The measurement of OCP transients is typically used to study some aspects of the chemical stability and corrosion processes of the surface layers on Mg alloys. It is the most rapid and sensitive way of detecting deterioration processes of the film, and the localized corrosion of Mg alloys in a corrosive solution. Localized corrosion of Mg alloys in an electrolyte containing chloride ions is characterized by the appearance of roughly circular blackened regions (pits), which expand radially with time and vigorously evolve hydrogen [3,4]. The corrosion reaction of Mg alloys in aqueous environments generally progresses by

The OCP transient of bare AZ31 in 0.1 mol/L NaCl solution disclosed two stages. In the first stage, within 1 h of immersion, the OCP increased from an initial negative value (about -1.6 V (vs SCE)) towards a more positive value (about -1.38 V (vs SCE)), indicating the formation and growth process of Mg(OH)₂ film on the AZ31 surface [3,4]. In the second stage, after 1 h of immersion, the OCP dropped suddenly from -1.38 V (vs SCE) to about -1.4 V (vs SCE), indicating the deterioration of the hydroxide film on the surface, leading to a localized corrosion reaction.

In contrast, the OCP transient of the MPCC sample was divided into three stages: a rapid increase from -1.5 to -1.36 V (vs SCE) within 2 h; a slight increase between 2 h and 24 h, dropped to a stable value of about -1.35 V (vs SCE) after about 24 h. In the first stage, the increased OCP indicates the decreased chemical activity on the MPCC AZ31 surface. This can be explained by the sealing effect produced by the MPCC during immersion in the NaCl solution. Since the MPCC on the AZ31 included micro-cracks (Fig. 3), the electrolyte could reach the substrate to react with the Mg alloy. The corroded product $Mg(OH)_2$ (reaction (9)) is formed, and it can seal the cracks which resulted in the rapid increase of OCP during the first 2 h of immersion (Fig. 5). In the second stage, the slow increase in OCP suggested that a dynamic equilibrium between the formation and dissolution of the film was reached. In the third stage, the OCP suddenly dropped, indicating that the film had damaged and the continuous corrosion reaction occurred on the surface. Thus, the initial pitting corrosion of MPCC was 24 h, which is much longer than that of the bare surface (about 1 h).

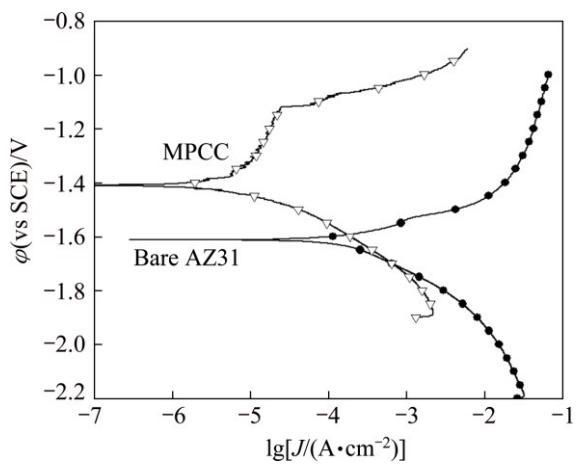
Fig. 6 Potentiodynamic polarization curves of bare and MPCC coated AZ31 samples at scan rate of 1 mV/s in 0.1 mol/L NaCl (MPCC was prepared by 20 min treatment in MPCC solution at $45 \text{ }^{\circ}\text{C}$)

Figure 6 shows the potentiodynamic polarization curves of bare and MPCC on AZ31 obtained after 1 h exposure to 0.1 mol/L NaCl solution at 25 °C. The bare AZ31 surface had a more negative corrosion potential (φ_{corr} =-1.61 V (vs SCE)) than that of the MPCC sample (φ_{corr} =-1.41 V (vs SCE)). The corrosion current density (J_{corr}) of MPCC sample was 6.9×10^{-3} mA/cm², which was reduced to about 3% of the bare surface (J_{corr} =2.23×10⁻¹ mA/cm²). Compared to zinc phosphate conversion coatings, MPCC showed more negative corrosion potential and had a little higher corrosion current density, but the MPCC was much more stable than zinc phosphate conversion coatings against corrosion under the salt-spray conditions, due to its compact coating [47].

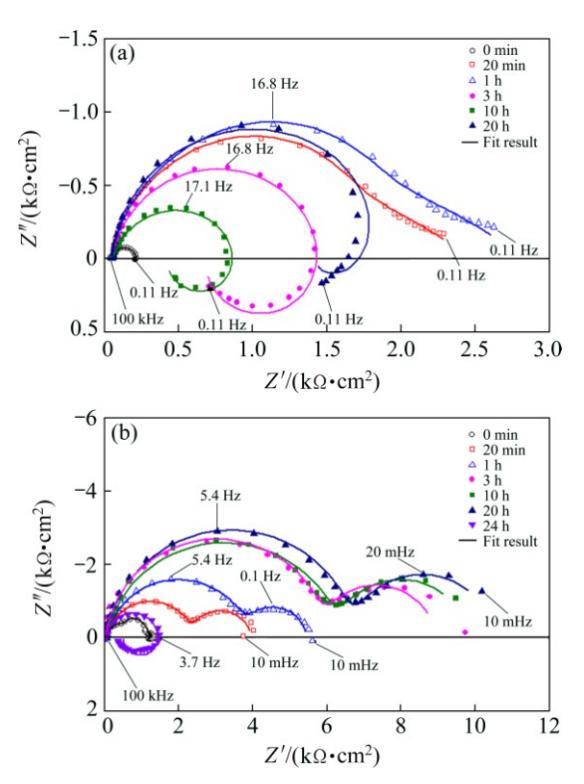
Fig. 7 Nyquist plots of bare (a) and MPCC coated (b) AZ31 samples after different immersion time in 0.1 mol/L NaCl solution at (25 ± 1) °C (MPCC was prepared by 20 min treatment in MPCC solution at 45 °C)

To further understand the corrosion behavior and the associated deterioration process of the bare and MPCC on AZ31, EIS was employed. Figure 7(a) shows the Nyquist plots of the bare AZ31 obtained after 0 min, 20 min, 1 h, 3 h, 10 h and 20 h exposure to 0.1 mol/L NaCl solution at 25 °C. EIS experiments of the bare AZ31 showed two capacitive loops at the high and middle frequencies (HF and MF) in combination with an inductive loop at low frequencies (LF). HF capacitive loops are usually attributed to both charge transfer and surface film effect [50,51]. MF capacitive loops are attributed to the relaxation of mass transport in the growing solid oxide phase. LF inductive loops are attributed to the phenomena of adsorption and desorption of Mg⁺ species on the surface of the Mg substrate, suggesting the slow corrosion reaction at the interface of AZ31 [11,14,50,51]. The typical EIS experiments of MPCC coated AZ31 consisted of two capacitive loops at HF and MF. According to SEM surface and crosssectional morphologies, the MPCC on AZ31 consisted of cracks, which reach deeply to the metal surface (Fig. 3). The cracks can be sealed by the corrosion product during immersion in the NaCl solution to form layers: a sealed layer and an unsealed layer. Thus, these two layers correspond to the two capacitive loops of the EIS experiment. The appearance of an inductive loop in the LF region after 24 h immersion is attributed to the localized corrosion of AZ31 due to the deterioration process of the MPCC [52].

used to fit the EIS spectra of MPCC on AZ31 with immersion time 24 h due to the occurrence of the localized corrosion process. The fittings were performed by using the Thales Z2.12 software and the fitted results are drawn as solid lines, together with experimental data, in Fig. 7.

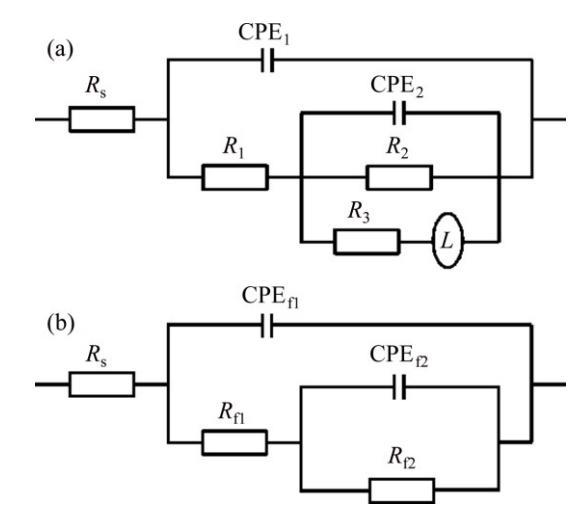
Fig. 8 Equivalent circuit models for simulation of Nyquist plots

Based on the impedance plots, the microstructure of MPCC, and the EIS studies of bare Mg alloy [50-52], two appropriate equivalent circuits were proposed for fitting these plots, as shown in Fig. 8. The equivalent circuits consist of two R/CPE components in series with $R_{\rm s}$, with or without inductive loop (*R/L*). The equivalent circuit presented in Fig. 8(a) was used to fit the EIS spectrum of the bare AZ31. The element R_s was the solution resistance, the R_1/CPE_1 and R_2/CPE_2 pairs were suggested to represent two capacitive loops at HF and MF as explained above. The R_3/L pair was suggested to represent inductive loops. The equivalent circuit presented in Fig. 8(b) was used to fit the EIS spectra of the MPCC coated AZ31. The $R_{\rm fl}/\rm CPE_{fl}$ and $R_{\rm f2}/\rm CPE_{f2}$ pairs were suggested to represent the two layers of MPCC during immersion in NaCl solution. The model presented in Fig. 8(a) with an inductive loop was also

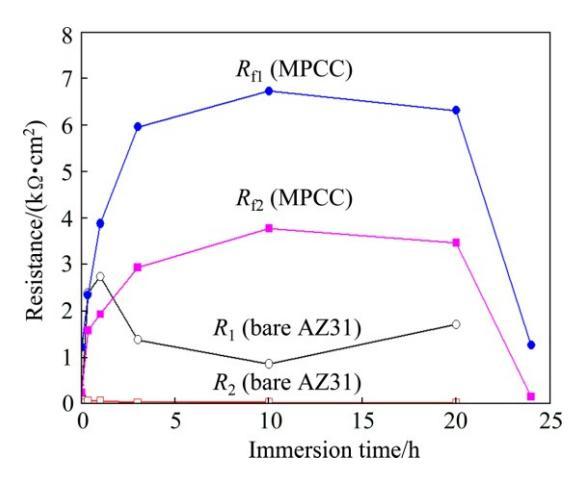
Fig. 9 Resistances of bare and MPCC coated AZ31 resulted from fitting on EIS spectrum by equivalent circuit models in Fig. 8

Considering the protective film formed on the bare and MPCC coated AZ31, the magnitudes of R_1 , R_2 , R_{f1} and R_{f2} were plotted with immersion time and shown in Fig. 9. For AZ31, the film resistance (R_1) is much larger than the mass transport resistance (R_2). The increase of R_1 during the first 1 h immersion indicates the growth of hydroxide film on AZ31. However, after an immersion time longer than 1 h, the rapid decrease of R_1 indicates the process of deterioration of the hydroxide film, where the localized corrosion occurs on the surface. The slight increase of R_1 with immersion time up to 20 h indicates that the surface of the AZ31 was completely covered by the corrosion product.

In contrast to bare AZ31, both R_{f1} and R_{f2} of the MPCC coated AZ31 rapidly increased to much higher value with increasing the immersion time from 0 to 3 h in 0.1 mol/L NaCl solution. As explained before, the corrosion product can be formed and seal the cracks of MPCC to increase the coating resistance. The sealing effect occurred strongly during the first 3 h of immersion in the NaCl solution, and became stabilized with immersion time longer than 3 h. After 24 h immersion, the sudden decreases of both R_{f1} and R_{f2} indicate the deterioration of MPCC and the initiation of localized corrosion on the surface. This result is in good agreement with OCP measurement (Fig. 5), where, OCP is rapidly increased within the first 3 h, and then, dropped after 24 h of immersion.

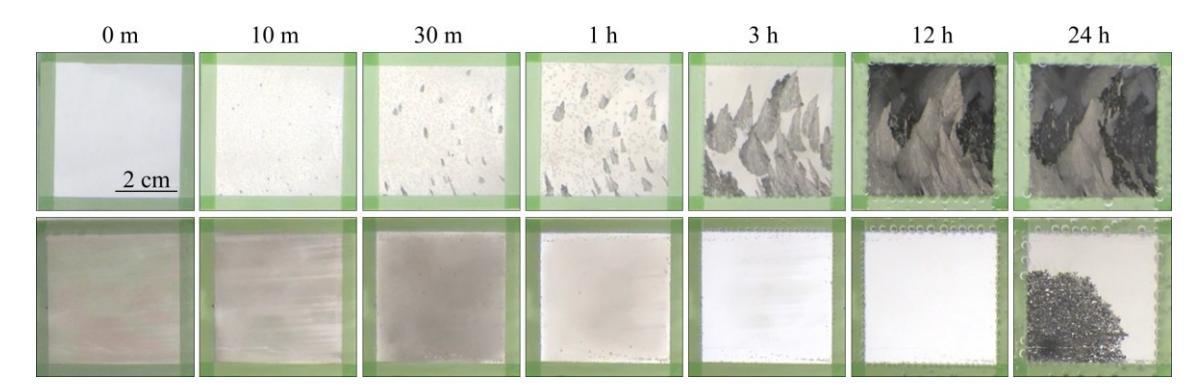
Fig. 10 Photographs of (a) bare and (b) MPCC coated AZ31 for 20 min with immersion time in 0.5 mol/L NaCl solution at (25±1) °C

Figure 10 shows photographs of bare and MPCC coated AZ31 with immersion time in 0.5 mol/L NaCl solution at 25 °C. The bare AZ31 showed pitting corrosion with a pit initiation time of about 10 min. The corroded sites rapidly expanded to the entire surface within 3 h immersion. In contrast, the MPCC coated AZ31 showed a filiform corrosion with a much longer pit initiation time of about 24 h. Thus, the immersion test again revealed that the MPCC can significantly increase the deterioration process of AZ31 magnesium alloy in NaCl solution.
