# Microstructure evolution of AA5052 joint failure process and mechanical performance after reconditioning with tubular rivet

**Abstract:** To extend the service life of the clinched joint, a reconditioning process conducted with an additional tubular rivet was proposed in this work. Different reconditioning forces were employed to produce dissimilar reconditioned joints by experimental method. The experimental results indicated that the neck fracture was the common failure mode of both original clinched and reconditioned joints. Compared with the original clinched joint, the shearing strength of the reconditioned joint produced by a reconditioning force of 40 kN increased from 1810.5 to 1986.47 N, and the energy absorption increased from 2.34 to 3.46 J. The range of effective reconditioning force was from 35 to 40 kN and 40 kN was the best choice for reconditioning the AA5052 failed joints. The mechanical properties of the reconditioned joints are obviously better than those of the original clinched joints, which fully demonstrates that the reconditioning method proposed in this work has a broad prospect of industrial application.

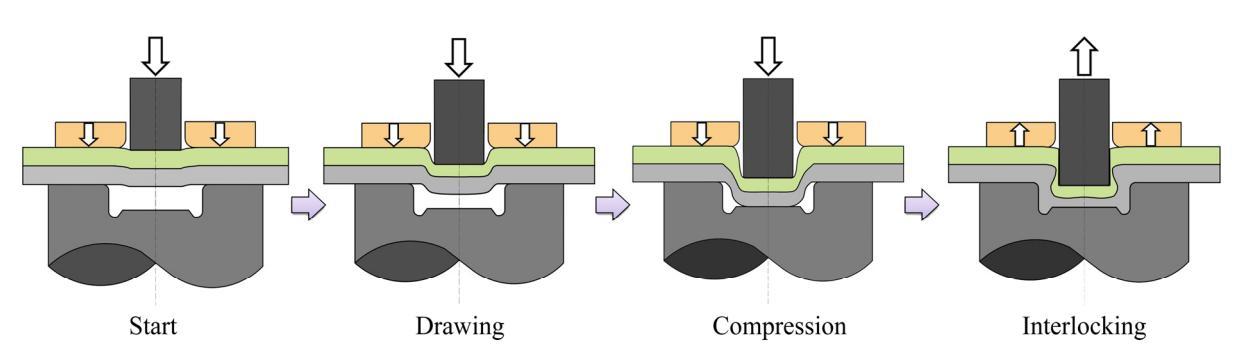
Fig. 1 Principle of mechanical clinching with fixed grooved die

connected material under the action of the punch and die. A mechanical interlock structure is formed to achieve the purpose of joining the sheet materials together. The clinching process conducted by the fixed grooved die is presented in Fig. 1.

Before the clinching process, the joined sheets are located between the fixed grooved die and the blank holder. Then, the punch exerts preload on the upper sheet under the action of the press. With the downward movement of the punch, the sheets are partially deformed, and the material in the deformed area is pushed into the groove of the fixed die. When the lower sheet touches the groove surface of the fixed die, the material axial flow of the joined sheets is blocked. As the punch moves downward, the bottom thickness of the joint decreases and most of the materials flow axially and fill the fixed grooved die slowly. When the loading force reaches the preset value, the punch stops pressing down and returns to the initial position. Finally, the mechanical clinching process is finished. Significantly, the absence of cracks in the joined sheets is a necessary condition for mechanical clinching [37]. Figure 2 shows the main geometric parameters of the mechanical interlock, including neck thickness  $(t_n)$ , undercut  $(t_s)$ , bottom thickness (X) and protrusion height (H). The specific roles of the main geometric parameters influence the mechanical properties of the joint directly. The protrusion height affects the application field and aesthetics of the joints in the industrial scenarios, while the relationship between the neck thickness and the undercut affects the failure mode and static strength of the joint in the static strength test directly. As for the bottom thickness, it is a key reference for judging the mechanical forming condition without damaging the joint and indirectly reflects the relationship between the neck thickness and the undercut.

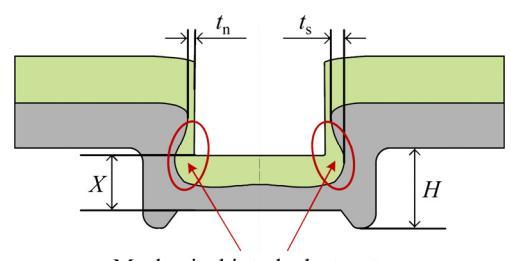
Mechanical interlock structure

Fig. 2 Geometric parameters of clinched joint

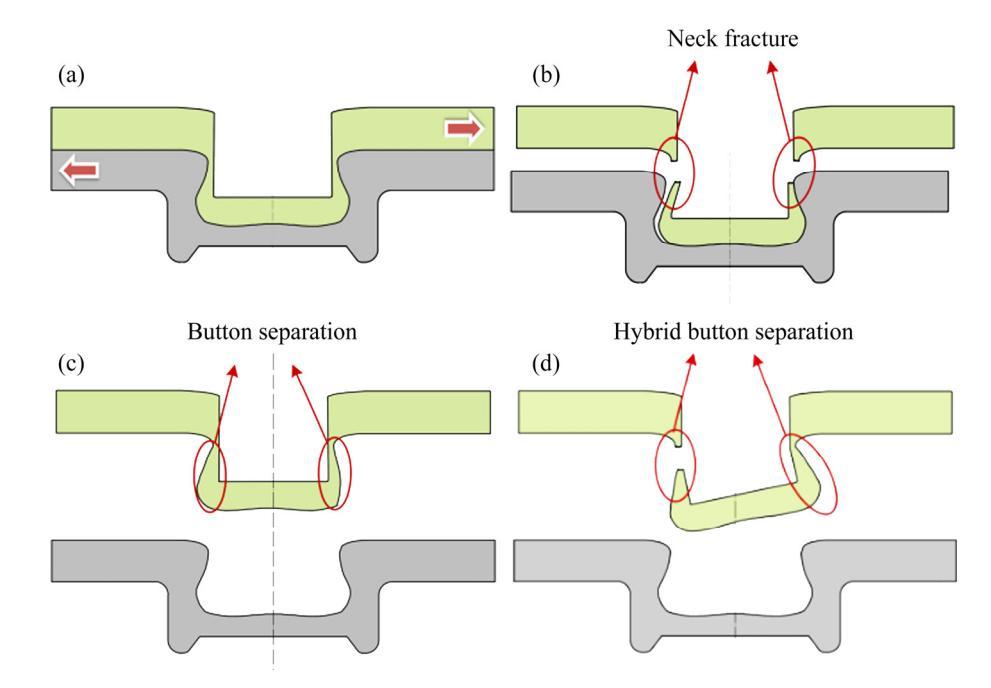
Fig. 3 Mechanism of joint failure: (a) Clinched joint under load; (b) Neck fracture; (c) Button separation; (d) Hybrid button separation

It is possible that many failure modes appeared during the joint service period such as static load failure, stiffness failure and fatigue failure. In this work, the joint failure process in the static single-lap tensile shear test is illustrated. The main failure modes and joint failure process are shown in Fig. 3. It is noticed that all the failure modes of the joints produced by the fixed grooved die in this study are neck fracture.

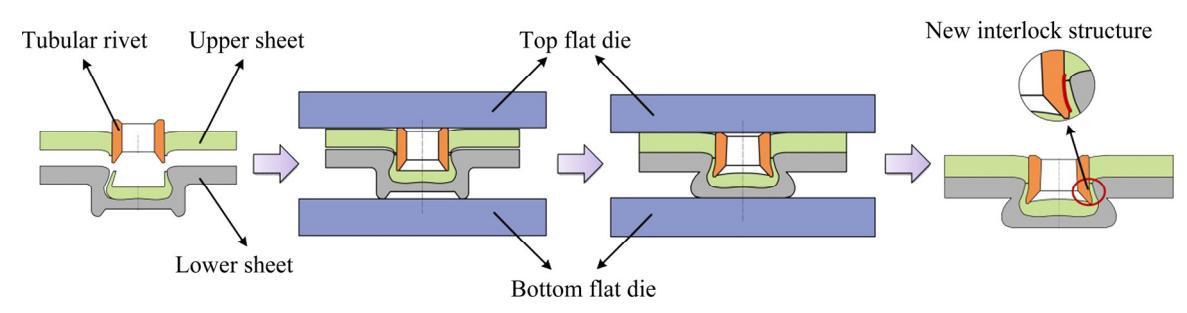
Fig. 4 Mechanism of mechanical reconditioning

Stable implementation of the reconditioning process is particularly important when a clinched joint fails or fractures. The reconditioned joint is required to have a similar strength to that before failure in order to meet the requirements for continued service. As depicted in Fig. 4, a pair of flat dies and a custom-built tubular rivet are used in the reconditioning process. Firstly, the tubular rivet is placed in the round hole of the upper sheet (the inner diameter of the hole is equal to the diameter of the custom-built tubular rivet). The joined sheets with the failed joint are placed between the top and bottom flat dies while on the premise of ensuring that the fracture area of the upper sheet is perfectly aligned with that of the bottom sheet. Then, the bottom flat die is fixed and the other flat die on top moves downward to compress the tubular rivet and exterior protrusion of the joint. With continuous loading, the tubular rivet is upset and plastically deformed. The upset rivet has an interference fit with the hole of the upper sheet. With the material flow of the tubular rivet, a new interlock structure is generated between the lower part of the tubular rivet and the lower sheet. Finally, the interlock structure reconnects the two layers of sheets together by the deformed rivet for the purpose of failed joints recondition.

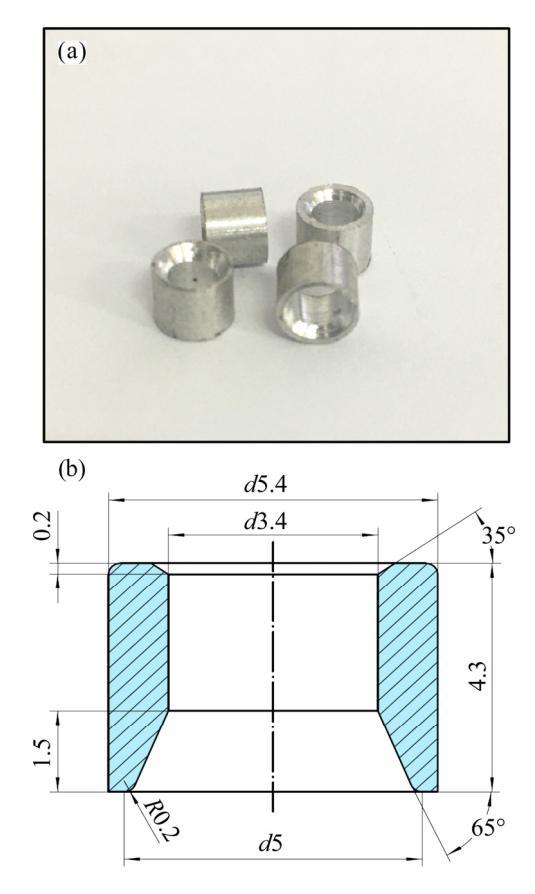
**Fig. 5** Custom-built tubular rivets (a) and cross-sectional geometries (b) used in reconditioning process (unit: mm)

sheets. To ensure consistency of sheet material for all experimental specimens, the AA5052 samples used for this experiment were cut into 25 mm  $\times$ 80 mm (width  $\times$  length) strips from a unique sheet. The AA6111 aluminum alloy was used for the custom-built tubular rivet material in this experiment. The mechanical properties of the experimental specimens and the custom-built tubular rivet were tested on MTS 322 physical property testing system. According to the tested results, the mechanical properties of AA5052 and AA6111 materials are depicted in Table 1. The custom-built tubular rivet and cross-sectional geometries of the rivet employed in the reconditioning process are shown in Fig. 5.

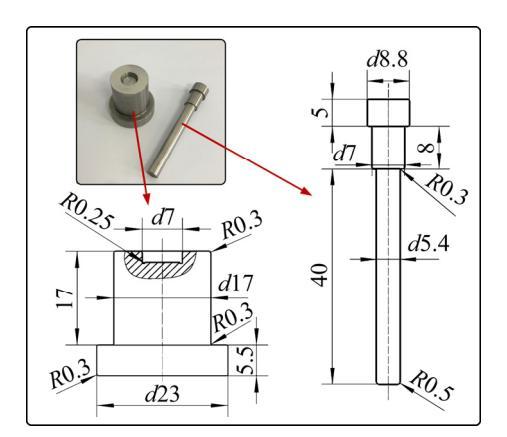
**Fig. 6** Geometries of punch and fixed grooved die used in clinching process (unit: mm)

In the process of clinching AA5052 sheets, a 5.4 mm diameter punch and a fixed grooved die were used to carry out the mechanical clinching experiment, of which the geometries are depicted in Fig. 6. The special experimental device is installed on a Sust CMT-5105GJ testing machine for the clinching process. The load and displacement changes in the whole operation process are monitored and recorded at any time. In the clinching process, the punch made of SKD-11 material moved downward with a precise speed of 4 mm/min to compress the joined sheets. During the experiment, the control mode of the testing machine

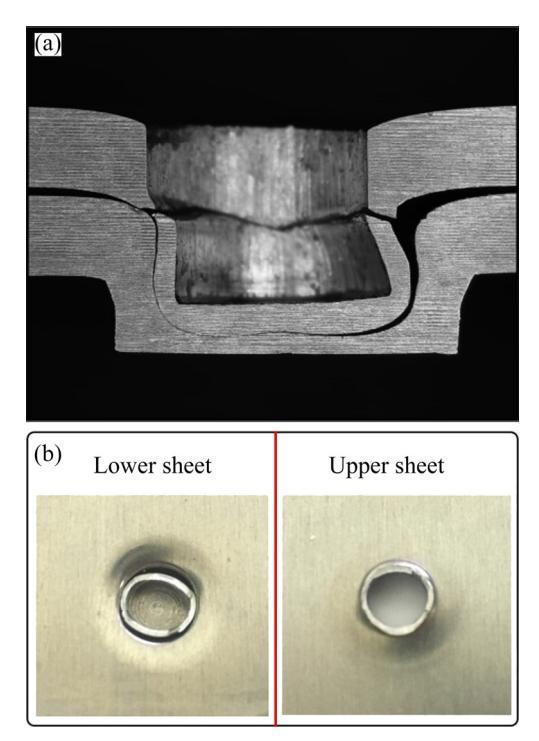
**Fig.** 7 Failure position of clinched joint: (a) Failed joint; (b) Failure part of sheets

In order to obtain the failed joint required for the reconditioning process, the clinched joint made in the previous section was destroyed to make it lose efficacy. This failure process imitated the common shearing load to perform shear failure on the clinched joint. The shearing process was also carried out on a Sust CMT-5105GJ testing machine, and the displacement and force changes during the failure process were recorded. The maximum load implemented on the joint before it failed was regarded as the shearing strength of the clinched joint [39]. The failure process was carried out at a constant speed of 2 mm/min until the upper and lower sheets were completely separated. As illustrated in Fig. 7, the fracture position of the joint is the neck of the mechanical interlock, while the bottom is slightly pulled out.

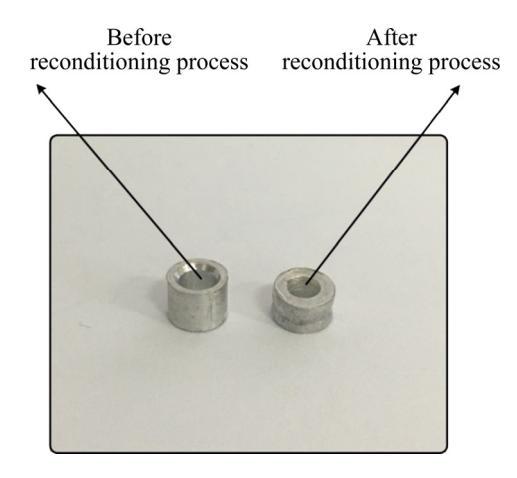
Fig. 8 Tubular rivet shapes before and after reconditioning process

When the clinched joint failed and new components cannot be replaced in time, the failed joint must be effectively reconditioned. Since the neck of the original mechanical interlock structure has been broken, a custom-built tubular rivet was employed to recondition the failed joint. The upsetting tubular rivet underwent the plastic deformation and a new interlock structure was generated to hook the upper and lower sheets together to achieve the purpose of reconditioning. A comparison photograph of the custom-built rivet shapes before and after reconditioning process is presented in Fig. 8.

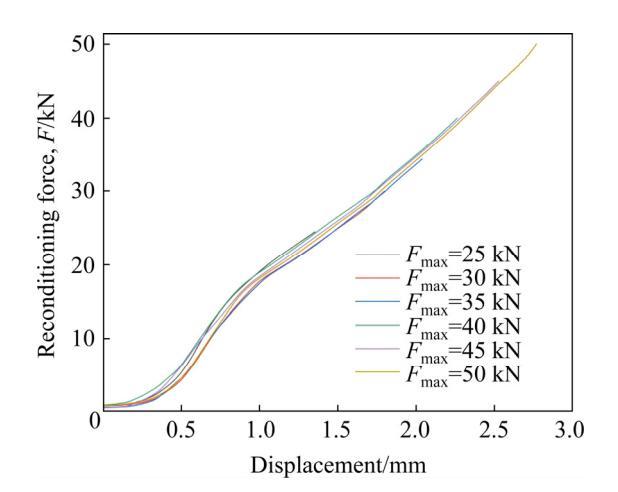
Fig. 9 Reconditioning evolution process with different forces

The reconditioning process was carried out on a Sust CMT-5105GJ testing machine with a constant speed of 2 mm/min. In order to investigate the effect of reconditioning force on the mechanical properties of reconditioned joints, the reconditioning forces of 25, 30, 35, 40, 45 and 50 kN were selected to reconditioning the failed joints in this work. Figure 9 shows the reconditioning evolution process with different

forces in this study. The displacement of the reconditioning process shows an overall positive correlation with the reconditioning force. In the initial stage of reconditioning, the displacement increment is larger, which is the process of tubular rivets being embedded in the pits of the bottom sheet. Subsequently, the force value increases sharply. At this time, the tubular rivet is severely deformed under the action of the reconditioning forces, and the exterior protrusion height is decreased. The interaction between the sheets and the rivet causes the material to flow radially, forming a new interlock structure.

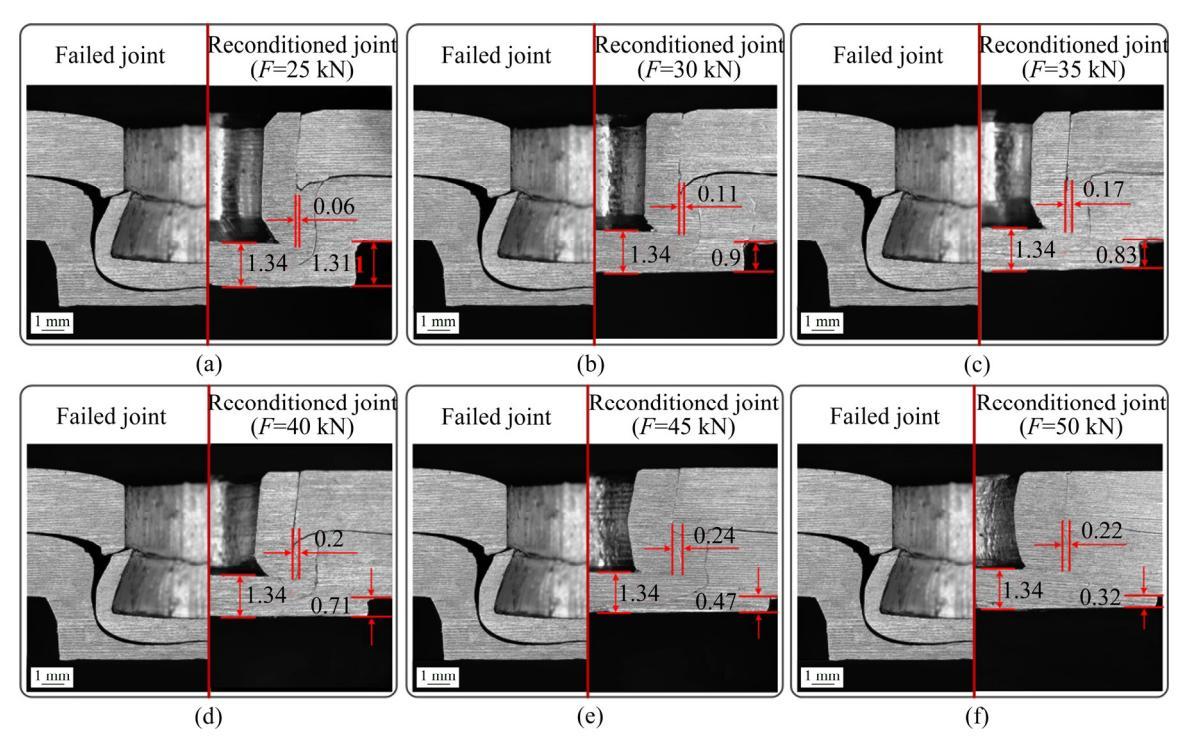
Fig. 10 Cross-sectional shapes and dimensions of dissimilar failed and reconditioned joints (unit: mm)

To facilitate observation of the failed and reconditioned joints, Fig. 10 demonstrates the cross-sectional profiles of dissimilar reconditioned joints and failed joints. The left side of each image is the failed joint, and the right side of each image is the reconditioned joints produced by different reconditioning forces, respectively.

The increase in reconditioning force from 25 to 50 kN can be regarded as the plastic deformation of the tubular rivets and generated new mechanical interlock structures in the reconditioning process. The use of tubular rivets restores the severely deformed upper sheet material embedded in the neck of the clinching point to the origin position before failure, which provides a prerequisite for severe deformation of the tubular rivet and formation of a new interlock structure. It can be seen from Fig. 10 that the deformation of the tubular rivet is very small at the reconditioning forces of 25 and 30 kN. The deformation of tubular rivet increases from 35 kN reconditioning force rapidly and reaches the maximum deformation at a

reconditioning force of about 40 kN. The inner wall of the tubular rivet presents a "C"-shape at the reconditioning forces of 45 and 50 kN, which is not conducive to the wrapping of the sheet material around the deformed rivet. This corresponds exactly to the relationship of reconditioned joint strength under different reconditioning forces.

As the reconditioning force increases, the exterior protrusion decreases significantly. The material in the protrusion position is subjected to radial flow by the combined action of the bottom flat die and the tubular rivet, which causes the diameter of the protrusion to increase with the decrease in height. In the reconditioning process, the tubular rivet is upset first, and as the reconditioning force increases, the tubular rivet is embedded in the bottom position of the upper sheet. Subsequently, the rivet material at the lower part of the tubular rivet flows in the radial direction. The surrounding sheet material also flows radially around until the deformed rivet forms a new interlock structure to tightly hook the two layers of sheets together.

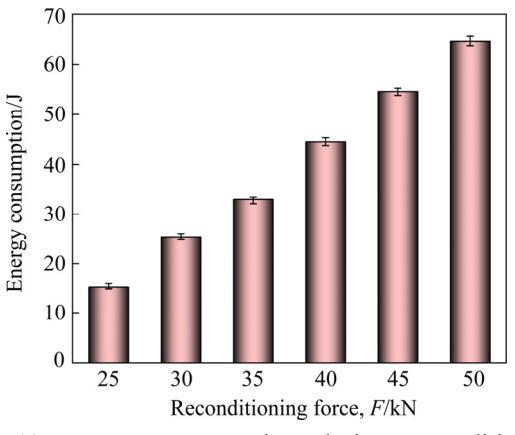
Fig. 11 Energy consumption during reconditioning process

The energy consumption represents the power dissipation of the reconditioning equipment during the reconditioning process, that is, the energy required during the reconditioning process. In order to explore the relationship between the energy consumption and optimal reconditioning force during the reconditioning process, the energy consumption in the reconditioning process was investigated. Figure 11 shows energy consumption of the failed joints reconditioned by different forces in the reconditioning process. As can be seen from Fig. 11, the energy consumption during the reconditioning process is positively correlated with the reconditioning force.

According to the experimental results, the energy consumption of the clinched joint produced by a fixed grooved die was 94.05 J in the forming process, which was much higher than the energy consumption of the reconditioning process. In terms of energy consumption, reconditioning a damaged joint was more energy-efficient than making a new clinched joint under the premise of ensuring the mechanical properties of the joint.

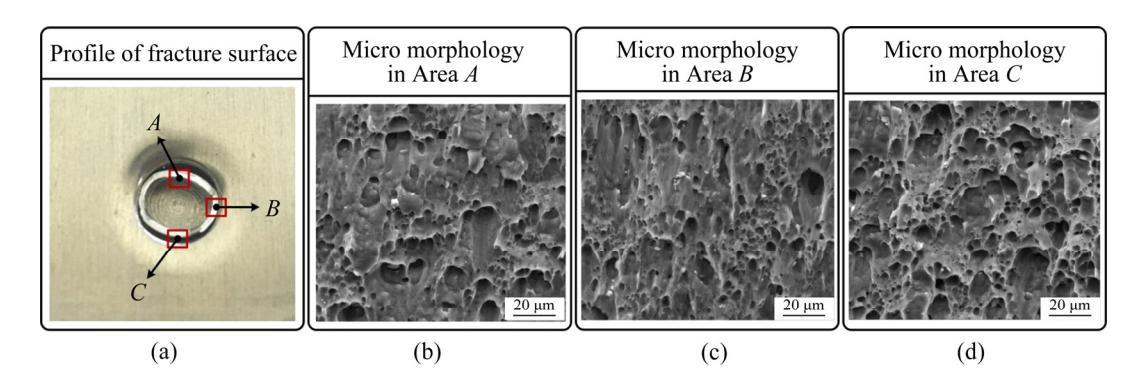
Fig. 12 Macro (a) and micro (b-d) morphologies of fracture position on failed clinched joint

For the clinched joints produced by the fixed grooved die, neck fracture failure mode and button separation mode are two main failure modes in the failure process [42]. If the bottom of the upper sheet is pulled out from the joint undercut on the lower sheet during the service stage, the failure mode is the button separation mode. If the thinnest area of the neck on the upper sheet is broken when overload or fatigue occurs, the failure mode is called the neck fracture failure mode [43]. In this study, the failure mode of all the clinched joints produced by the fixed grooved die is neck fracture. Figure 12 demonstrates the fractured neck location of the failed joint in macro and micro views.

Figure 12(a) shows the macroscopic profile of the fractured neck on the upper sheet. As can be seen, the macroscopic appearance of the fracture is

not neat, and Area A is elongated. From the micro morphology in Area A (Fig. 12(b)), the material presents a fibrous and radial distribution, and a small number of microspores appear on the surface of this area. Further, a number of elongated dimples appear along the same direction; these characteristics indicate that this is a typical ductile fracture area. As can be seen in Fig. 12(c), a large number of short and curved tearing ridges and microspores, as well as river-shaped cracks radiating from the center of the point-shaped crack source to the surroundings, are observed in the microscopic image of Area B. Therefore, the fracture form of the material in Area B is the quasi-cleavage fracture. There are a large number of cleavage steps, elongated dimples and large microspores that are unevenly distributed in Area C(Fig. 12(d)). The cleavage steps and the tearing ridges deformed by local plastic deformation constitute the river pattern which can absorb more energy before fracture. Thus, cleavage fracture is the main fracture form in Area C. In summary, the failure process of the clinched joint starts from the microspores in Area A, extends to Area B and develops into a micro-crack, and finally breaks completely in Area C.

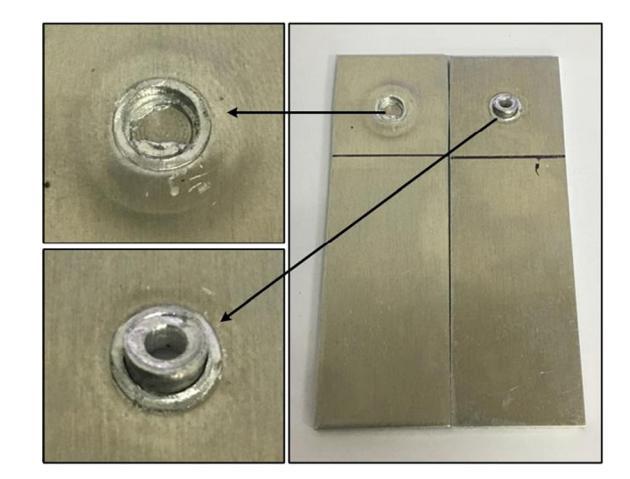
Fig. 13 Failure mode of reconditioned joint

As for the failure mode of the reconditioned joint, all the tubular rivets are pulled out from the bottom sheet along with the upper sheet shown in Fig 13. Figure 14 illustrates the fractured location of the reconditioned joint in the single-lap tensile shear test. Areas D, E and F of the reconditioned joint after the shear strength test in Fig. 14(a) correspond to Areas A, B and C of the failed clinched joint in Fig. 12(a). As can be seen in Figs. 14(b), (c) and (d), instead of elongating the dimples in all three areas, the raised tear ridges were flattened. The fibrous and radial distribution

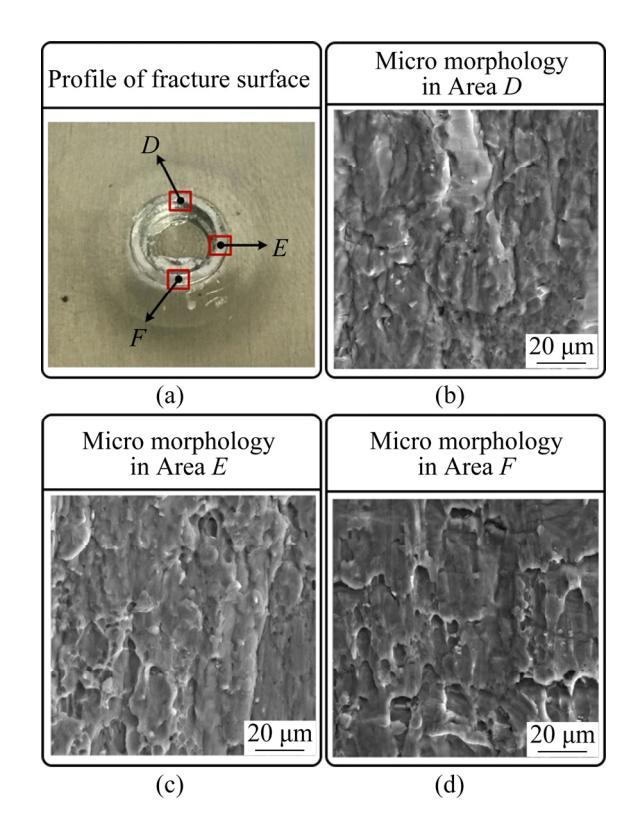
**Fig. 14** Macro and micro morphologies of fracture position on failed reconditioned joint

material disappears in Areas D, E, and F. Furthermore, the microspores and the elongated dimples become relatively flat. This is caused by the relative extrusion of the upper and lower sheets during the reconditioning process. The failure mode of the reconditioned joint indicates that the fractured neck of the reconditioned joint loses its function completely in the process of shear strength test. The reconditioning of the joint wholly depends on the insertion of the tubular rivet.

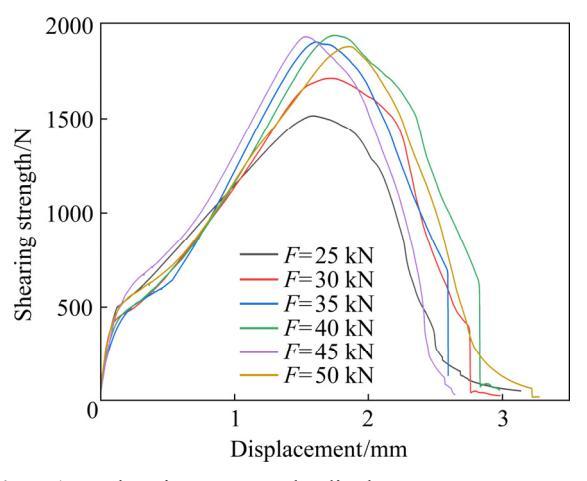
Fig. 15 Shearing strength-displacement curves of reconditioned joints in single-lap tensile shear test at different reconditioning forces

For the reconditioning of failed joints, the most critical evaluation criterion is the comparison of the mechanical properties of the reconditioned joint with those of the clinched joint before failure. The reconditioning process has engineering significance only if the joint strength after reconditioning is greater than or equal to the strength before failure. Figure 15 shows the shearing strength-displacement curves registered in the single-lap tensile shear test on reconditioned joints with various reconditioning forces of 25, 30, 35, 40, 45 and 50 kN, respectively. All the singlelap shear force curves of the reconditioned joints produced by different reconditioning forces have the same tendency in the single-lap tensile shear test. The shearing strength of clinched joint before failure is 1810.5 N. Figure 16 depicts the average shearing strength of the reconditioned joints produced by different reconditioning forces in the single-lap tensile shear test.

As can be seen from Figs. 15 and 16, the displacement of the reconditioned joint during failure did not increase significantly in the singlelap tensile shear test. The shearing strength of the reconditioned joint was much lower than that of the clinched joint when the reconditioning force was insufficient (25 and 30 kN). However, with the increase of reconditioning force, the shearing strength of the reconditioning joint was improved significantly, reaching the maximum strength of 1986.47 N at a reconditioning force of 40 kN, which was 9.74% higher than that of the original clinched joint. When the reconditioning force increased again, the shearing strength of the reconditioned joint decreased slowly and showed a sharp decline at the reconditioning force of 50 kN.

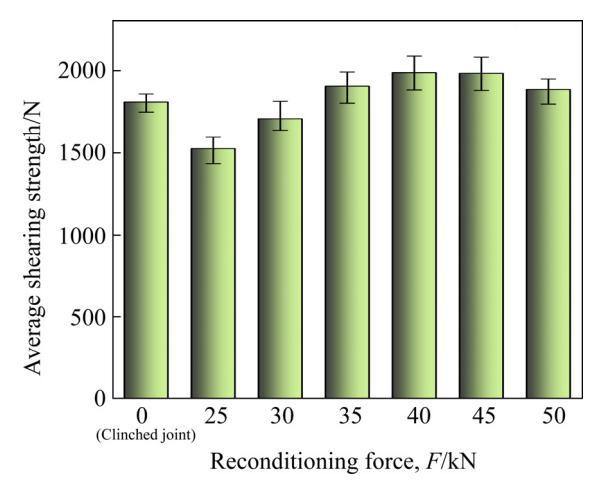
**Fig. 16** Shearing strengths of clinched and reconditioned joints in single-lap tensile shear test

industrial use when the reconditioning force was insufficient (20 and 30 kN), and its strength only reached 84.25% and 94.43% of the clinched joint strength before failure, respectively. When the reconditioning force was more than 35 kN, the shearing strength of the reconditioned joint was higher than that of the clinched joint before failure. Excessive reconditioning power not only increased energy consumption but also was not conducive to the improvement of the strength of reconditioned joints. When the reconditioning force was greater than 40 kN, the strength of the reconditioned joint began to decrease with the increase of the reconditioning force. Therefore, the selection range of reconditioning force was 35-40 kN, and the reconditioning force of 40 kN was the best choice when using this type of custom-built tubular rivet to recondition the failed joint made by a fixed grooved die.

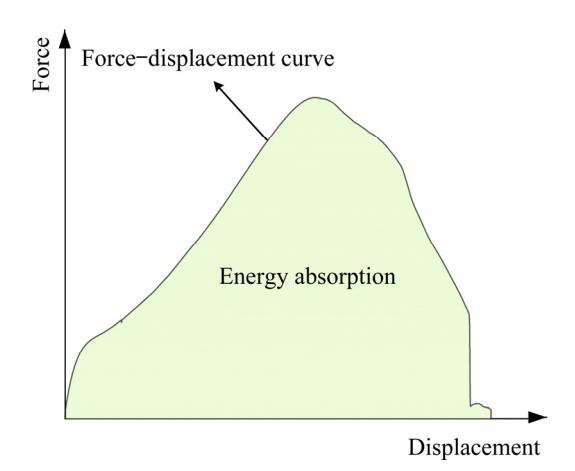
Fig. 17 Energy absorption diagram for single-lap tensile shear test

Energy absorption is another critical feature in the analysis of the mechanical properties of joint. According to the ISO 12996: 2013 standard, the energy absorption can be determined by calculating the area between the force-displacement curve and the *x*-axis. As shown in Fig. 17, the energy absorption is exactly described as the integral of the force-displacement curve along the direction of the failure displacement.

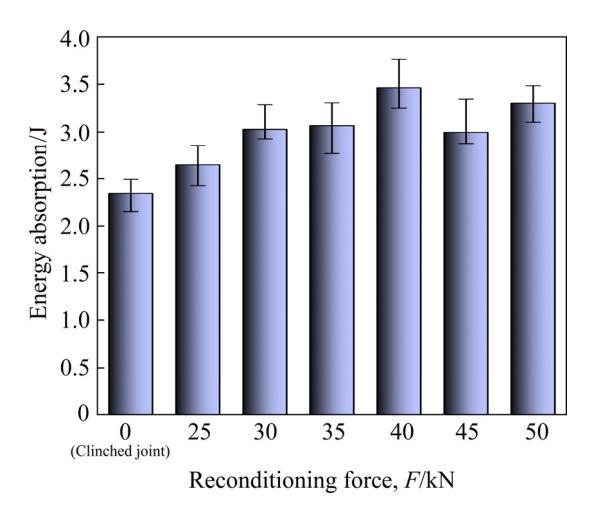
**Fig. 18** Energy absorption of clinched and reconditioned joints in single-lap tensile shear test

To examine the rationality of the energy absorption of the reconditioned joints, each type of five reconditioned joint failure tests were performed in this study. The energy absorption of the clinched and reconditioned joints in the single-lap tensile shear test is presented in Fig. 18.

As can be seen in Fig. 18, the energy absorption capacity of the reconditioning joint is significantly improved after the reconditioning process compared with clinched joint. The energy absorption of the original clinched joint is 2.34 J. The energy absorption of reconditioned joint produced at 25 kN is the lowest, which is 2.65 J, while the reconditioned joint produced at 40 kN has the highest energy absorption value, which is 3.46 J. When the reconditioning force is less than 40 kN, the energy absorption of the reconditioned joint is positively correlated with the reconditioning force. When the reconditioning force is greater than 40 kN, the increase in reconditioning force is not conducive to the increase in energy absorption, that is, the reconditioning process consumes more energy, but absorbs less energy when the reconditioned joint fails, which is obviously not conducive to energy-saving strategy.

Overall, all of the reconditioned joints had higher energy absorption than the clinched joint before failure. Compared with the clinched joints before failure, the energy absorptions of the reconditioned joints formed by the reconditioning forces of 25, 30, 35, 40, 45 and 50 kN were increased by 12.93%, 29.24%, 30.94%, 47.76%, 27.91% and 41.02%, respectively. The energy absorption of reconditioned joints under a reconditioning force of 40 kN was the highest, which was 3.46 J. The energy absorption of reconditioned joints under a reconditioning force of 25 kN was the lowest, which was 2.65 J. The experimental results prove that the reconditioned joints have more excellent mechanical properties than the initial clinched joints before failure.
