Trans. Nonferrous Met. Soc. China 23(2013) 1002-1010

# Cavitation and electrochemical characteristics of thermal spray coating with sealing material

Key words: thermal spray coating; sealing material; cavitation; electrochemical characteristics

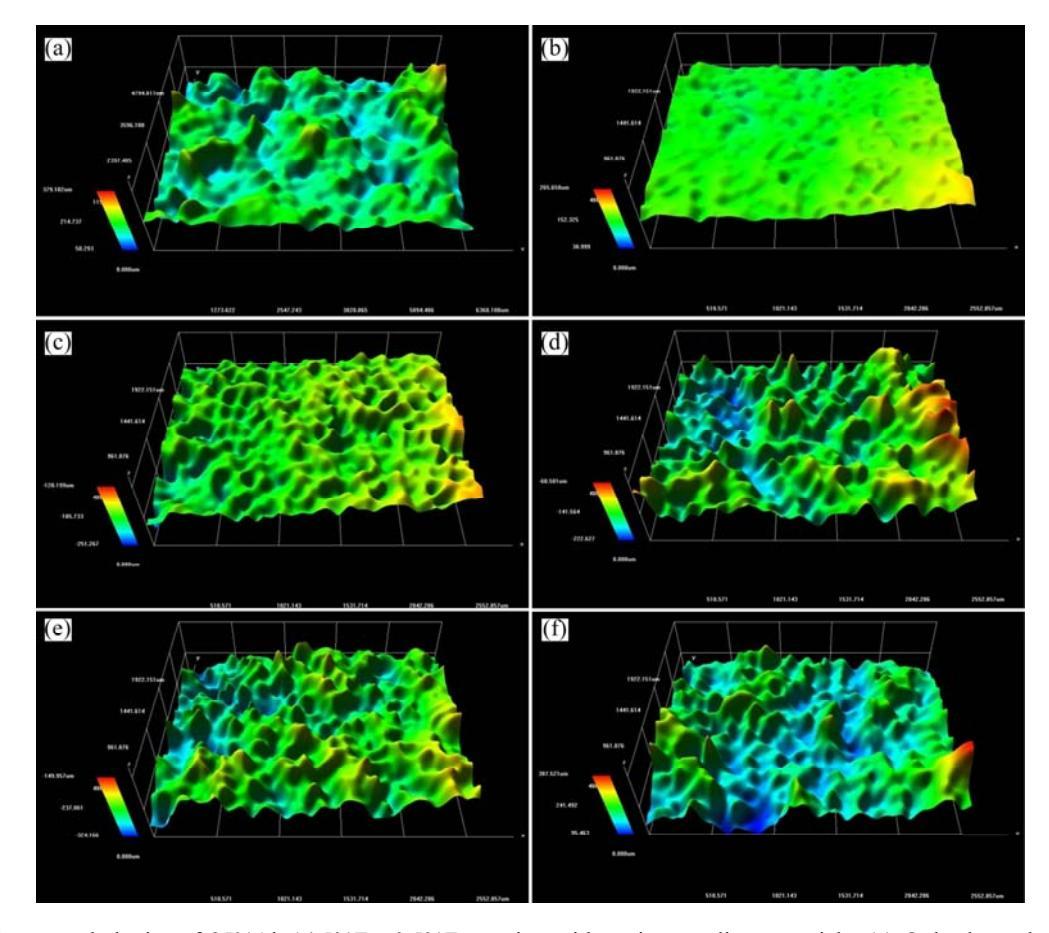
**Fig. 1** Surface morphologies of 85%Al-14.5%Zn-0.5%Zr coating with various sealing materials: (a) Only thermal spray coated; (b) Epoxy; (c) Nano; (d) W-F; (e) Ceramic; (f) F-Si

Figures 1 and 2 show the changes of surface morphology by sealing material after thermal spray coating with 85%Al-14.5%Zn-0.5%Zr alloy and compare the average roughness  $(R_a)$  using a roughness analysis program, respectively. The surface roughness  $R_{\rm a}$ is the average of the absolute values from the center of height variation to the profile of the surface within the cutoff. The same cutoff was applied to all the specimens under different conditions to compare their measurements of average roughness. The unsealed surface of thermal spray coating layer was rough and many pores could be observed. The highest measured  $R_a$

was 6.895 µm. On the other hand, the specimen sealed with epoxy showed relatively very smooth surface and no surface defects or pores could be seen. The lowest measured  $R_a$  was 0.655 µm among the sealed specimens. That was expected to affect the corrosion characteristics. The surface sealed with nano sealing materials was little rougher than that with epoxy materials, with the  $R_a$  value of 2.614  $\mu$ m, indicating a relatively even surface. The  $R_a$ values of W-F, ceramic, and F-Si sealing materials were 4.339, 5.378 and 5.979 µm, respectively. The surface morphologies showed rough surfaces similar to the base metal. When the  $R_a$  values in each condition were compared between different sealing materials after the thermal spray coating with 85%Al-14.5%Zn-0.5%Zr, the  $R_a$  value decreased by 90.5% for epoxy sealing material, 62.1% for the nano sealing material, 37.1% for the water-soluble fluorine, 22.0% for ceramic sealing material, and 13.3% for fluoro-silicon sealing material, over the base metal. As shown in Fig. 2, among the measured R<sub>a</sub> values of various specimens, the epoxy sealing material was the best. The surface roughness affects the erosion and corrosion characteristics of the surface, thus epoxy and nano sealing materials which showed low roughness can offer better corrosion resistance than other materials.

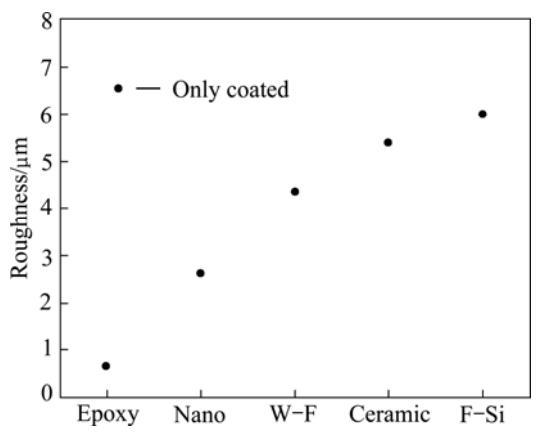
Fig. 2 Roughness of 85%Al-14.5%Zn-0.5%Zr coating with sealing materials

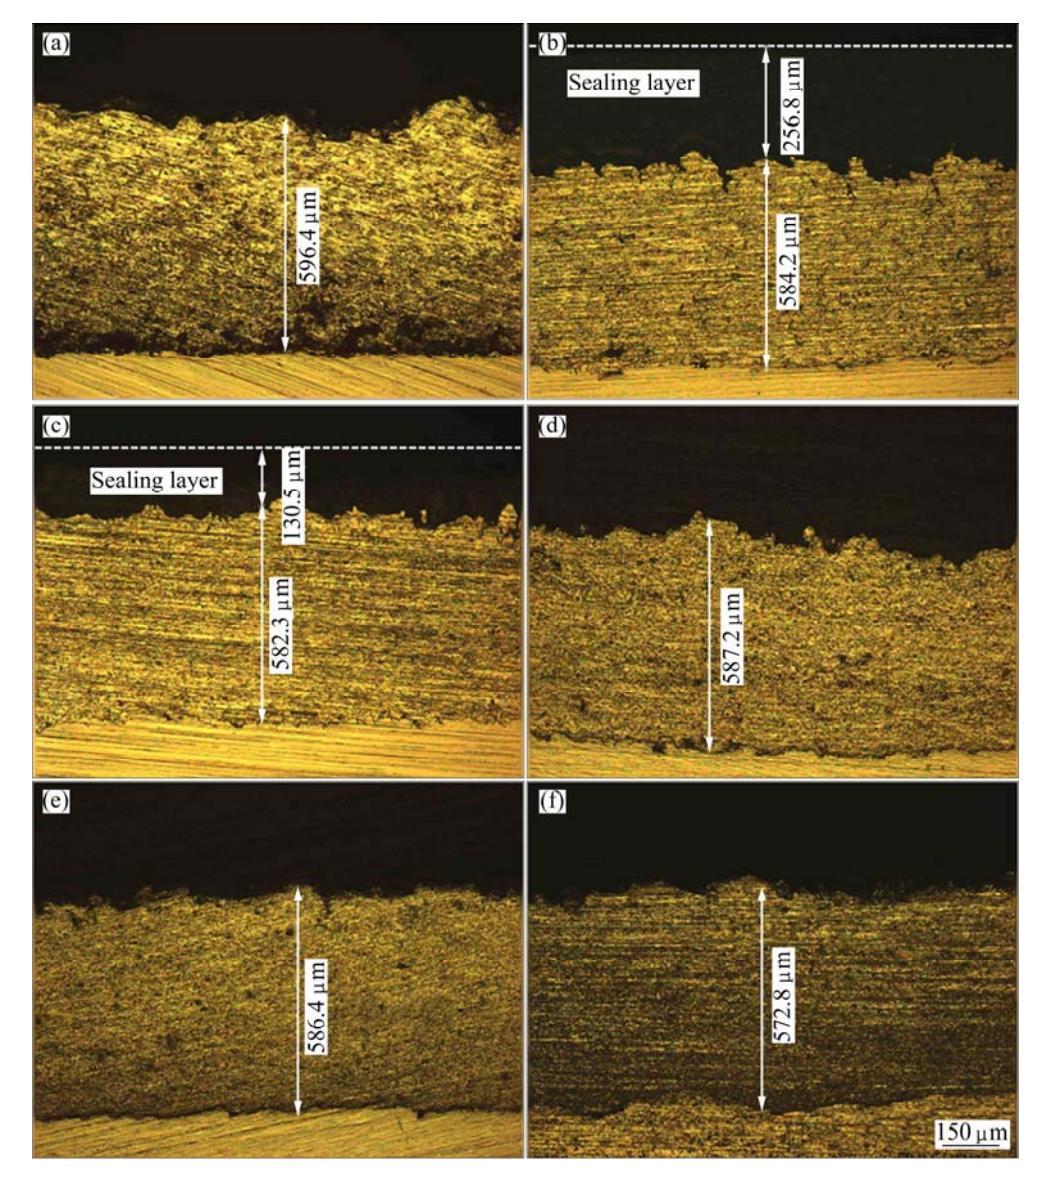
**Fig. 3** Cross-sectional morphologies of 85%Al-14.5%Zn-0.5%Zr coating with different sealing materials: (a) As-sprayed; (b) Epoxy; (c) Nano; (d) W-F; (e) Ceramic; (f) F-Si

Figure 3 compares the side observation results of different sealing materials after thermal spray coating with 85%Al-14.5%Zn-0.5%Zr. The coating layers were similar, ranging from 572.8 µm to 596.4 µm with a small difference of about 13 µm. This small difference is due to the irregular laminating process during the thermal spray. Since the same thermal spray was applied, the adhesiveness to the base metal will be similar. Furthermore, the coating layer was formed well with few pores in all conditions, but it still showed a little difference depending on the sealing material. No sealing material was observed in three specimens excluding those with epoxy and nano sealing materials, due to the

fact that the sealing material was absorbed into the coating layer. The thicknesses of the epoxy and nano sealing materials were 256.8 µm and 130.5 µm, respectively, and they showed clear interface between the sealing layer and the thermal spray coating layer. Almost no defects were observed at the interfaces between the base metal and the coating layer and between the coating layer and the sealing layer, suggesting very sound bonding. On the other hand, a small number of micropores were observed inside the coating layer. These micropores of the coating layer could exhibit shock buffering effect or maximize corrosion resistance effect by inhibiting the generation of hydrogen in the coating that contacts solutions by electrically insulating the anode and cathode through sealing or painting. Even if the base metal was exposed to seawater due to defects caused by pores or oxide layer, the base metal electrochemically acted as cathode and the thermal spray coating layer acted as anode; and if micro-galvanic cells were formed, the thermal spray coating layer could play the role of sacrificial anode and will exhibit corrosion resistance effect for the base metal.

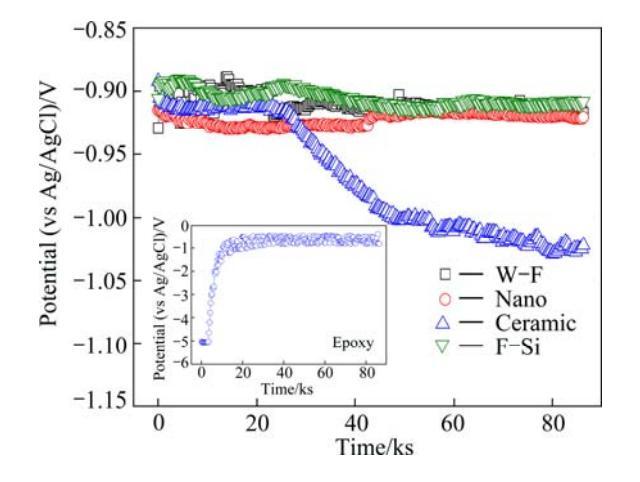
Fig. 4 Potential measurement of specimen in seawater with different sealing materials after thermal spray coating with 85%Al-14.5%Zn-0.5%Zr

Figure 4 shows the open circuit potential measurements of the specimen in seawater for 86400 s with different sealing materials after thermal spray coating with 85%Al-14.5%Zn-0.5%Zr. For watersoluble sealing materials, the potential during the initial stage of immersion was -0.929 V, after which it alternated between rising and falling; the potential stabilized at -0.917 V after around 23000 s at the end of the experiment. For nano-fluorine sealing material, the potential was -0.915 V in the early stage of immersion and slowly moved toward the active direction; after around 15300 s, the potential remained at -0.92 V. At around 43000 s, the potential rose sharply and remained stable until the end of the experiment. For the hybrid ceramic sealing material, the potential was around -0.91V in the early stage of immersion and rapidly moved toward the active direction from 24000 s to 48000 s. After this, the potential decreased slowly and indicated the active potential of -1.02 V at the end of the experiment. For the fluoro-silicon sealing material, the potential alternated between rising and falling, but it generally remained stable, and indicated -0.90 V at the end of the experiment. For the salt-tolerant epoxy sealing material, the potential was as low as -5.06 V in the early stage of immersion, and then steadily increased until 20000 s and remained constant after that. It showed the very noble potential of -0.56 V, due to the excellent environment-blocking effect of the compact coating layer. Therefore, we could not expect the effect of sacrificial anode from the salt-tolerant epoxy sealing material as it showed a higher potential than the base metal (KR-RA steel: -0.7 V). In the case of 85%Al-14.5%Zn-0.5%Zr

which was coated before sealing, chlorine ions in the seawater penetrated into the voids in the coating layer with decreased potential [9]. As a result, it showed the potential of -0.979 V at the end of the experiment. After sealing with water-soluble fluorine, nano-fluorine, and fluoro-silicon, the potential became nobler than this which improved corrosion resistance. It might be because the sealing materials filled the voids and restricted the penetration of chlorine ions.

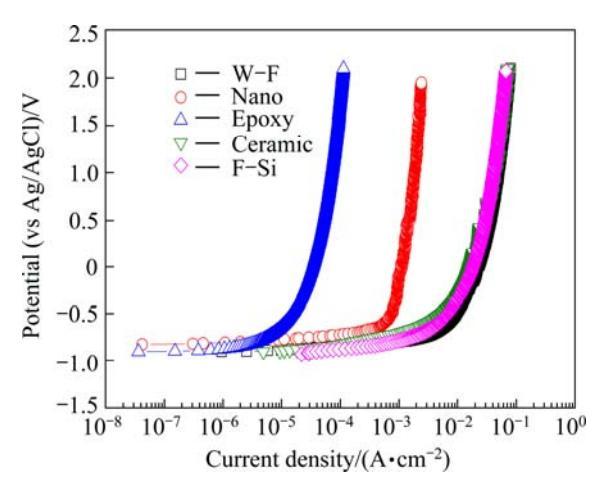
**Fig. 5** Anodic polarization curves of specimen in seawater with sealing materials after thermal spray coating with 85%Al-14.5%Zn-0.5%Zr

Figure 5 presents the anodic polarization trend for different sealing materials after thermal spray coating with 85%Al-14.5%Zn-0.5%Zr. The open circuit potentials were similar in general, and a steady increase of current density was observed with increasing potential with no passive tendency in all conditions. However, the current density varied greatly as the potential increased. The salt-tolerant epoxy sealing material showed a very

low current density compared with other conditions. The reason for this appeared to be that the electrochemical behavior is dependent on the characteristics of surface the coating layer has coating, and excellent environmental blocking effects as seen from the measurements of open circuit potential. The fluorosilicon, hybrid ceramic, and water-soluble fluorine sealing materials showed similarly high current densities. Aluminum alloys in seawater environment maintain corrosion resistance to some degree due to the re-passivation, by which the passive films of  $Al_2O_3$  or Al<sub>2</sub>O<sub>3</sub>·3H<sub>2</sub>O are destroyed or recreated by chlorine ions (Cl<sup>-</sup>) in seawater. However, no passivation was observed for the test materials in this study.

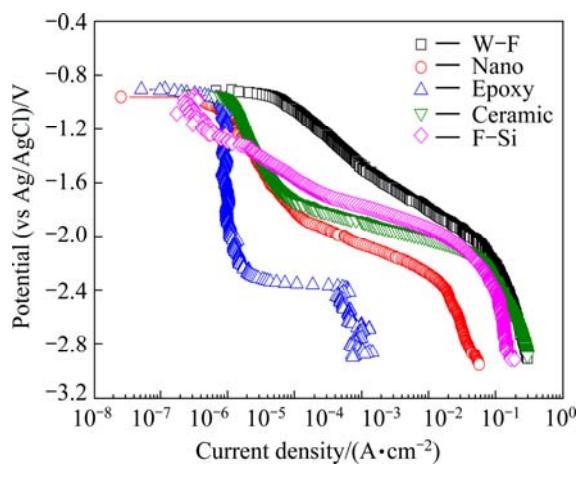
**Fig. 6** Cathodic polarization curves of specimen in seawater with sealing materials after thermal spray coating with 85%Al–14.5%Zn–0.5%Zr

Figure 6 depicts the cathodic polarization trend with different sealing materials after thermal spray coating with 85%Al-14.5%Zn-0.5%Zr alloy. The cathodic polarization of the metals immersed in seawater solution generally exhibits two distinct reactions: concentration polarization by the reduction of dissolved oxygen  $(O_2+2H_2O+4e \rightarrow 4OH^-)$  and active polarization by hydrogen gas generation  $(2H_2O+2e \rightarrow H_2+2OH^{-})$ [10-12]. For the water-soluble fluorine and fluorosilicon sealing materials, however, concentration polarization and active polarization trends were not observed, and the current density slowly increased as the potential moved toward the active direction. The hybrid ceramic sealing material showed the trend of concentration polarization in the range from -1.884 V to -0.984 V, and the current density ranged from  $1.015 \times 10^{-6}$  A/cm<sup>2</sup> to  $1.010 \times 10^{-4}$  A/cm<sup>2</sup>. Besides, the nano-fluorine sealing material showed concentration polarization trend in the similar range (-2.057 to -1.030)V) as the hybrid ceramic sealing material, but its current density was little lower than that of the hybrid ceramic sealing material. The salt-tolerant epoxy sealing material

most clearly showed the concentration polarization and active polarization trend, and the lowest current density of  $10^{-6}$ A/cm<sup>2</sup> between -2.243 V and -0.979 V. The current density rose sharply at potential under -2.4 V, but it was considerably lower than the potential of other sealing materials. And the salt-tolerant epoxy sealing material showed a very low current density at potential under -2.4 V even though it was a hydrogen embrittlement section by the generation of hydrogen gas in almost all conditions. Thus, the salt-tolerant epoxy sealing material was also highly resistant to hydrogen embrittlement.

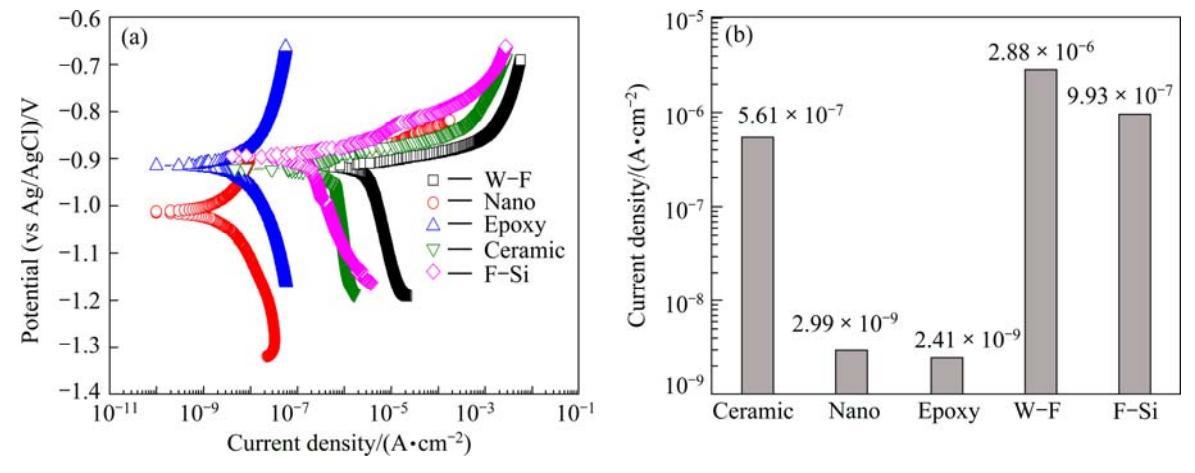
Fig. 7 Polarization curves for Tafel analysis (a) and corrosion current density (b) in seawater with different sealing materials after thermal spray coating with 85%Al-14.5%Zn-0.5%Zr

Figure 7 shows the polarization curves of Tafel analysis in seawater with different sealing materials after thermal spray coating with 85%Al-14.5%Zn-0.5%Zr. For the water-soluble fluorine sealing material, the current density rose slowly in the cathodic polarization curve, and the current density increased steadily according to the rising potential in the anodic curve. When the current density was the highest among the applied sealing materials, its corrosion speed was the fastest in static condition. For the nano-fluorine sealing material, the corrosion potential was the lowest, and the pitting corrosion potential appeared at -0.897 V, at which the current density increased sharply. This trend was not observed in other sealing materials. The salt-tolerant epoxy sealing material showed low corrosion current density and high corrosion potential, which suggested excellent corrosion resistance. When the corrosion current density was compared, the water-soluble fluorine sealing material showed the highest value, whereas the nano-fluorine and salt-tolerant epoxy sealing materials showed considerably low corrosion current density, indicating a strong resistance to corrosion.

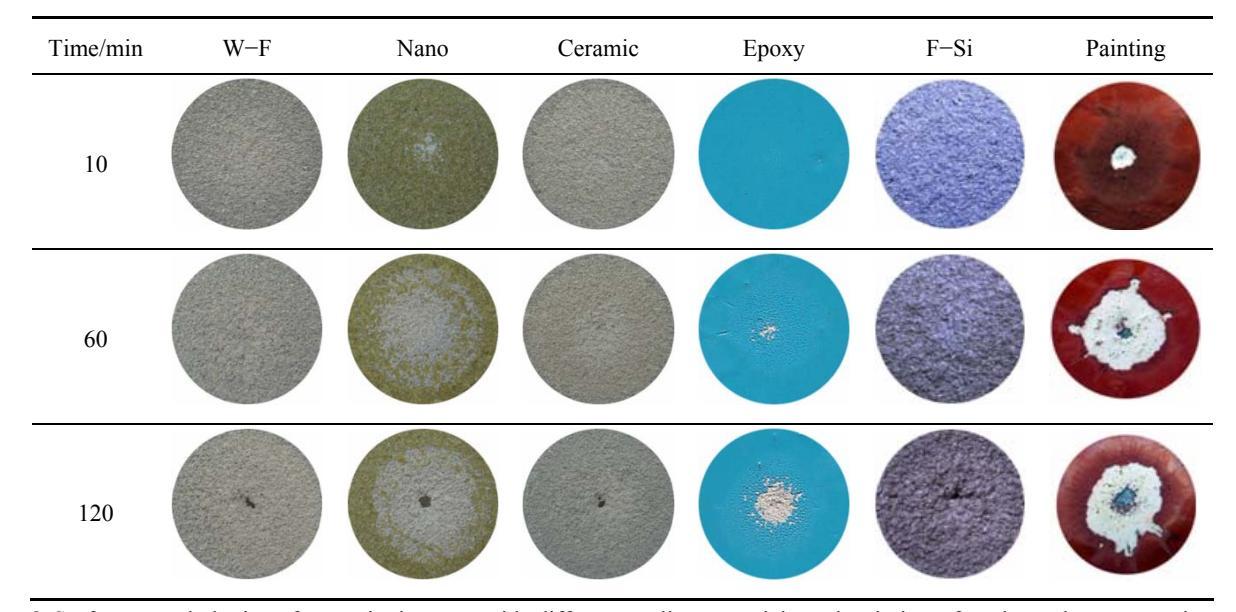
Fig. 8 Surface morphologies after cavitation test with different sealing materials and painting after thermal spray coating with 85%Al-14.5%Zn-0.5%Zr

Figure 8 shows the observation results of the surface morphology according to cavitation time in various

sealing materials and painting after thermal spray coating with 85%Al-14.5%Zn-0.5%Zr. After about 10 min, only the painted specimen was damaged. At 20 min, the hybrid ceramic sealing material discolored over a wide area. For the nano-fluorine sealing material, the surface sealing was a little damaged. At 30 min, a damage was observed at the center of the hydrogen water-soluble sealing material, and the center of the salt-tolerant epoxy sealing material began to be damaged. At 60 min, a damage at the center of the hybrid ceramic sealing material specimen was observed, and the damages of all specimens began to accelerate from this moment. At 90 min, the base metal of the hybrid ceramic sealing material and the nano-fluorine sealing material began to be revealed. At 120 min, the base metals began to be revealed at the center of all specimens and the revealed area of the base metal increased over time.

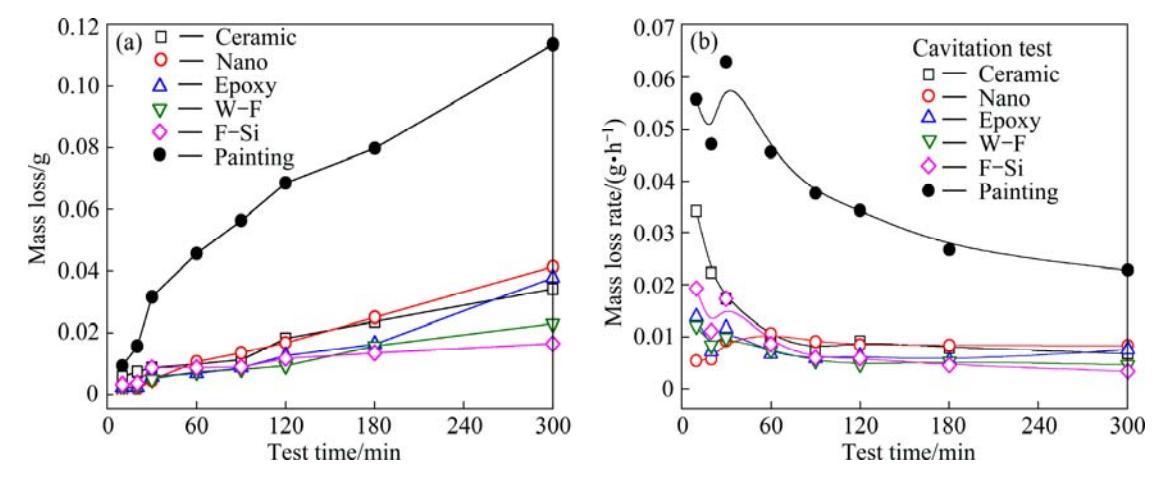
Fig. 9 Mass (a) and mass loss rate (b) after cavitation test in seawater with sealing materials and painting after thermal spray coating with 85%Al-14.5%Zn-0.5%Zr

Figure 9 shows the curves of mass loss and mass

loss rate with cavitation time of different sealing materials and painting after thermal spray coating with 85%Al-14.5%Zn-0.5%Zr. As shown in Fig. 9(a), the mass loss continuously increased over time for all the five sealing materials in all sections, and the mass loss rate of the painted materials steadily increased from the start to the end of the experiment. The nano-fluorine sealing material showed the lowest mass loss initially, but the mass loss increased over time and became greater than those of other sealing materials at the end of the experiment. The hybrid ceramic sealing material showed the greatest mass loss in the initial stage of experiment, but almost no increase of the mass loss was observed from 30 min to 90 min. Then, from 120 min, its mass loss increased slowly. The salt-tolerant epoxy sealing material showed relatively low mass loss in the early stage, but it increased sharply after 180 min. After 300 min, it showed the second highest mass loss after nano-

fluorine sealing material. For water-soluble fluorine sealing material, the mass loss increased a little between 20 min and 30 min, and then it remained low. For the fluoro-silicon sealing material, the mass loss increased a little in the first 20 min and sharply increased at 30 min. After 90 min, the mass loss increased steadily, indicating the lowest mass loss. The specimens that were sealed after thermal stray coating showed a mass loss 1/5 to 1/3times lower than those of the specimens painted at the end of the experiment, giving improved anti-cavitation characteristic. The consumption rates by cavitation over time were compared. The painted material showed much higher mass loss rate than other sealing materials from the start of experiment. The hybrid ceramic sealing material showed a consumption rate that was 2.5-7 times higher than other sealing materials in the early stage of experiment, and the consumption rate sharply decreased after that and stabilized after 60 min. While the nano-fluorine sealing material exhibited the lowest consumption rate in the early stage, but it increased until at 60 min of experimental time and maintained a higher consumption rate than other sealing materials. The salt-tolerant epoxy sealing material alternated between rising and falling after a high consumption rate in the early stage, and after 60 min it became generally stabilized. The water-soluble sealing material showed a small width of change and the consumption rate decreased a little after 180 min. The fluoro-silicon sealing material showed a high consumption rate at 10 min and it decreases by half after 20 min and rapidly increased until 30 min. After that, the consumption rate sharply decreased until 60 min and stabilized after 90 min. Consequently, the cavitation consumption rate considerably improved compared with the painted case. The fluoro-silicon showed the lowest consumption rate, indicating the best resistance to cavitation.

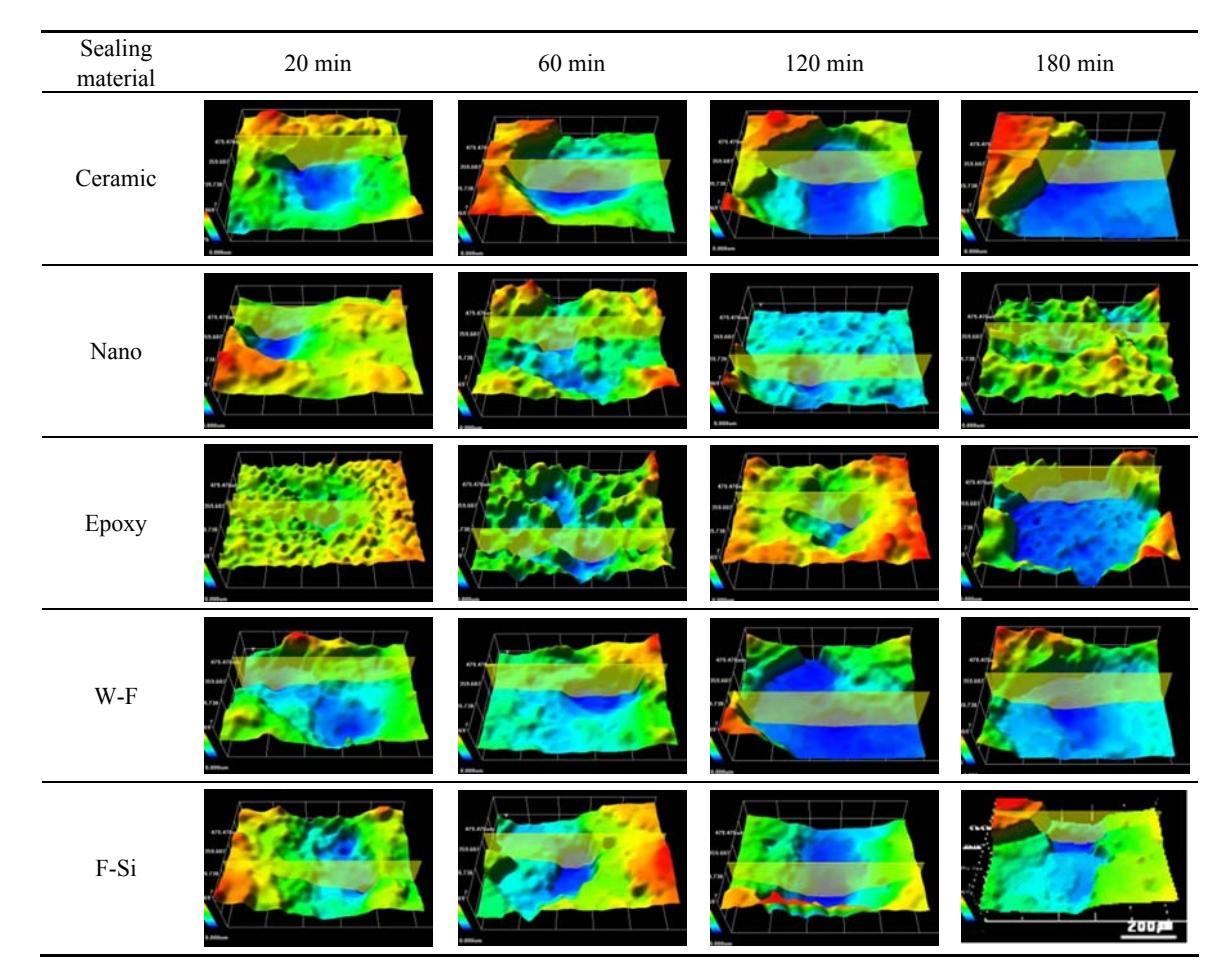
Fig. 10 Surface morphologies of specimen after cavitation test in seawater with sealing materials after thermal spray coating with 85%Al-14.5%Zn-0.5%Zr

Figures 10 and 11 show the morphologies of

damaged surfaces and the maximum damage depth taken with a 3D microscope after the cavitation experiment for specimens coated with various sealing materials, respectively. The ceramic sealing material showed steady damages starting with 117 µm from 10 min to 60 min, and a relatively large damage was observed at the center of specimen after 20 min of the experiment time. The damage progressed in the depth direction and the maximum depth steadily increased until 60 min. After that, the damages in the edges accelerated more than in the center and the depth began to be relatively shallower. Pitting increased again in the depth direction at 120 min and the largest depth of damage of 399 µm appeared at 180 min. At 300 min, the coating layer in the edges with relatively poor erosion resistance began to be damaged and a shallow damage depth of 95 µm was observed. The nano sealing material showed the lowest damage depth among the five sealing materials, and the greatest damage depth of 200 µm was observed at just 20 min. The damage depth became gradually lower and decreased to 30-80 µm after 60 min. The epoxy sealing material showed rough surface morphology due to pitting at 20 min. After that, pits were combined to increase damages and the surface became flat. As the damages accelerated in the depth direction, most of the base metal was revealed at 180 min. For the water-soluble fluorine sealing material, a large pitting with the depth of 144 µm occurred at just 10 min, and damages by pitting corrosion progressed at 20 min, but the maximum damage depth did not increase. And the surroundings became flat at 30 min and damages occurred again in the depth direction, reaching the maximum damage depth of 223  $\mu$ m. After that, the depth became lower from 60 min to 90 min as nearby pits were combined due to continued shock which flattened the surface. At 120 min, the pit at the center grew in the depth direction and reached the maximum depth of 354 µm. The microscope pictures

also showed that a large part of the base metal at the center began to be revealed. At 300 min, the damage depth decreased to 75  $\mu$ m. The reason for the decreased damage depth is that even though the base metal was partially damaged, the base metal was exposed due to the damage of the surrounding coating layer with relatively

poor erosion resistance. For the fluoro-silicon sealing material, a damage with the depth of 615 µm was observed at 60 min. The reason for this is that a pitting developed at the center of the specimen, and its growth in the depth direction accelerated until 60 min. The pictures also show that the pitting is larger and the peeled surrounding coating layer progressed more at 60 min than at 20 min. In addition, at 90 min and 120 min, the surrounding coating layer was damaged and flattened with the growth of the pitting, which decreased the maximum damage depth. At 180 min, the peeling speed of the surrounding coating layer was faster than the growth of the center pitting in the depth direction, and as the base metal was revealed, the damage depth increased to 609 µm. At 300 min, the damage depth decreased because the erosion progressed more in the surrounding area with relatively low strength due to the exposed base metal. The pictures of the damaged surface and the graph of the measurements of the maximum damage depth do not agree with the mass loss and cavitation rate in Fig. 9 because the exposed time is different due to the difference in the resistance to cavitation of the coating layer.

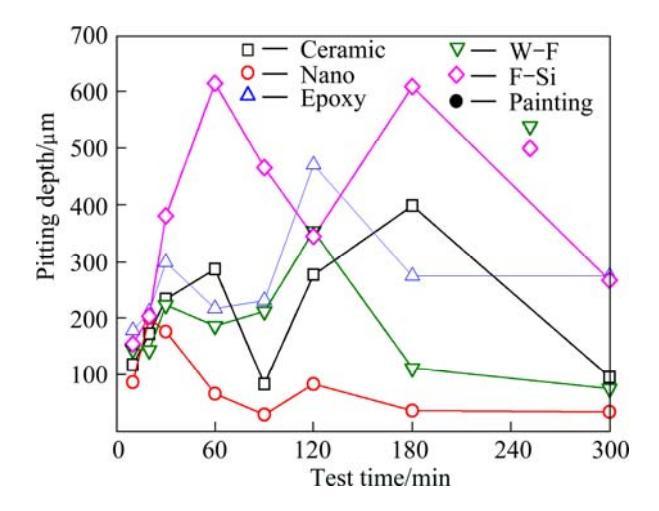
Fig. 11 Maximum damage depth taken with 3D microscope after cavitation experiment
